**Material Testing Laboratory  
of the State of Brandenburg -**

**Examination Report**

No. 1.3/00/3664

Contents Material examination of a part of the starboard front bulkhead  
of the ferry "Estonia" in order to prove mechanically caused  
structure deformations.

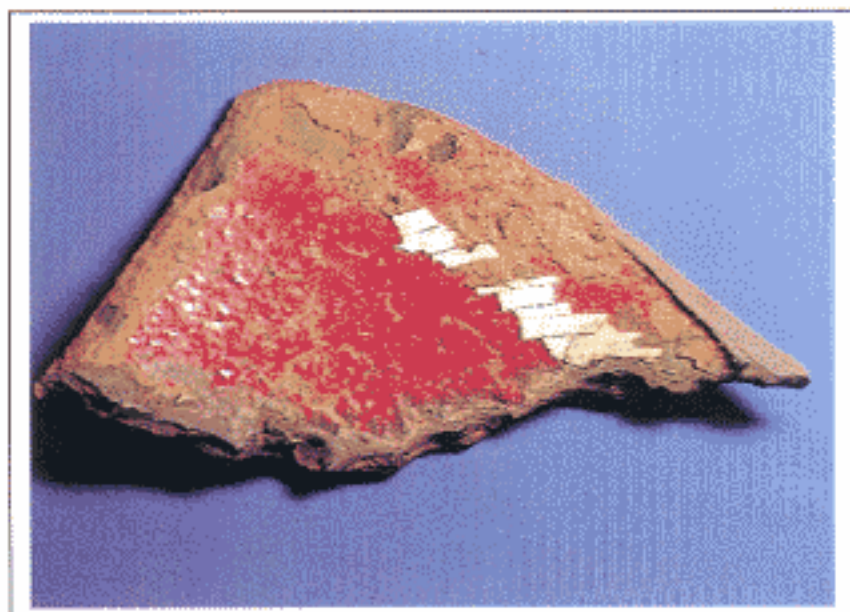
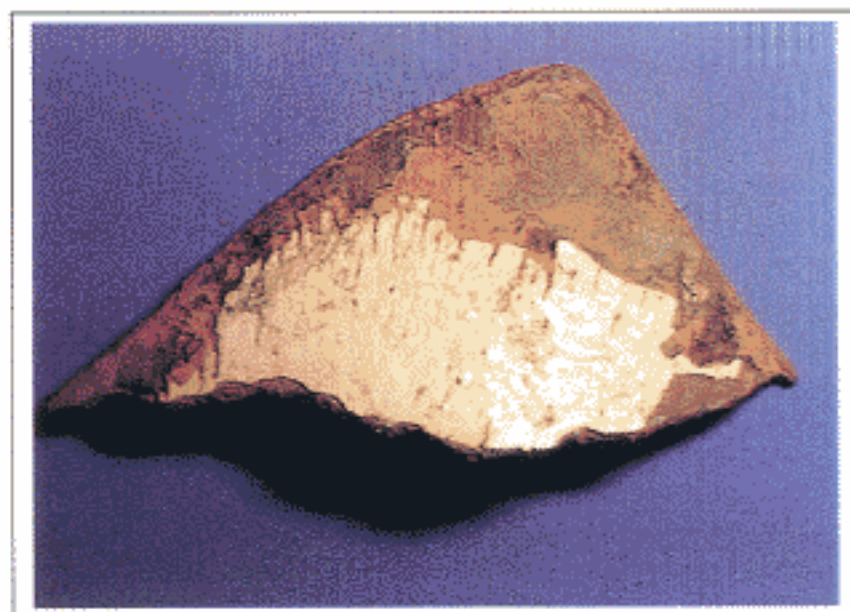
The triangular steel sample of the starboard front bulkhead has according to clients two sides (cathodes) which are fracture edges and one side (hypotenuse) which was flame-cut during cutting off of the sample. The fracture edges and the parts of the surfaces are corroded. The area marked side 1 shows besides red paint remains also partly broken parts of the white top layer. This side is according to clients the outside of the bulkhead. The area marked side 2 is, besides the mentioned corroded parts, exclusively covered by white paint. (Pictures 1, 2.)

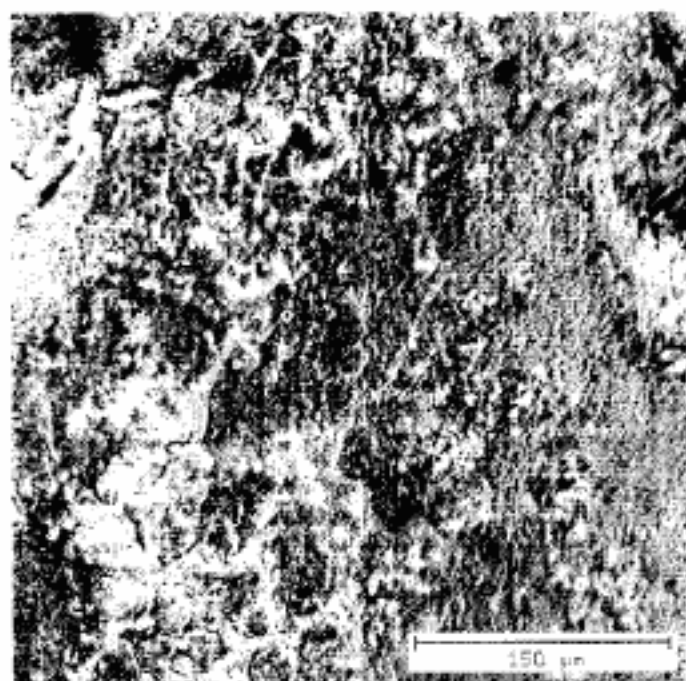
Bild 8 REM-Aufnahme der Bruchfläche mit dicker Schicht der Korrosionsprodukte, Probe 1.3/00/3664 V021

Due to the extensive corrosion appearance it was no more possible to establish on the fracture surface indications of its characteristics. The fracture surface does not show a uniform appearance picture. Besides the areas with a thick layer of corrosion products - specimen 1.3/00/3664 V021 (picture 8) and specimen 1.3/00/3664 V011 (picture 10) – there are areas recognizable where part of the corrosion layer is cracked off (pictures 11 and 12). The chemical composition of the surface areas shown by the pictures is compiled in *Table 2*. The composition of the fracture surface area with the thick corrosion layer shows a high iron and oxygen content as well as a relatively high silicium concentration, which cannot be explained by the silicium content of the steel (*Table 2, column 2-4*). The silicium distribution of the fracture surface area shown on picture 8 is shown on picture 9. Accordingly the silicium is mainly present in 5-10 µm big particles. It has to be assumed that small sand particles are contained in the layer of corrosion products.

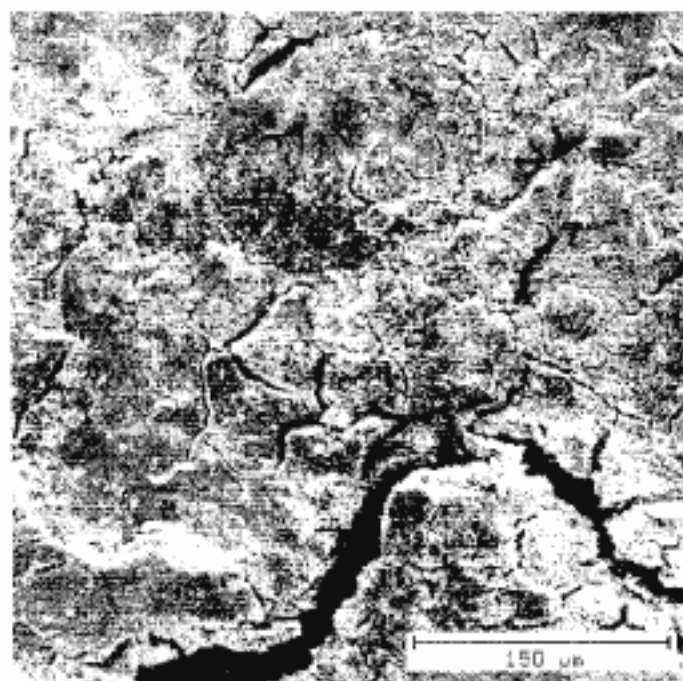
Bild 10 REM-Aufnahme der Bruchfläche mit dicker Schicht der Korrosionsprodukte, Probe 1.3/00/3664 V011

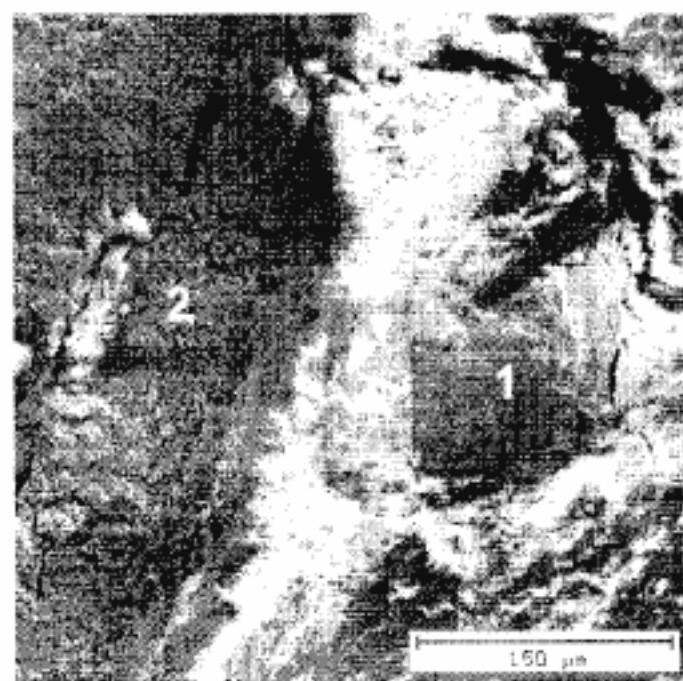
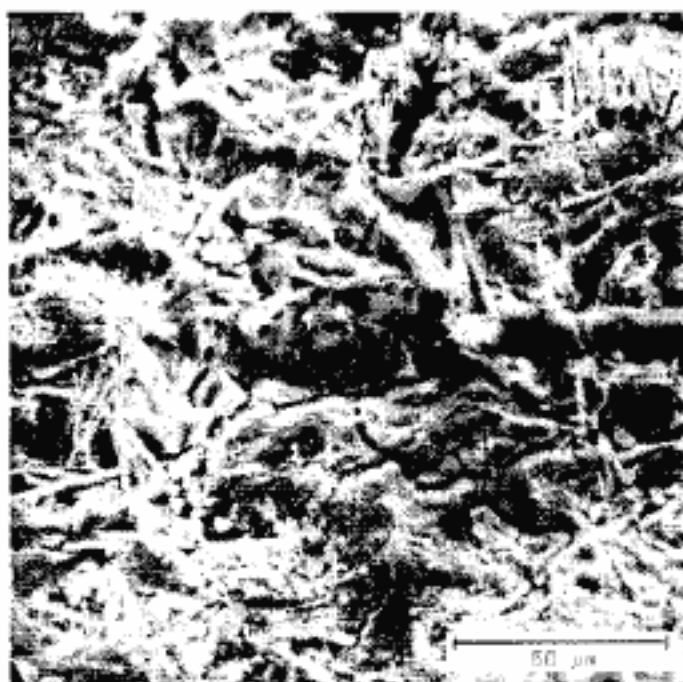
In the fracture surface areas, where a part of the layer of corrosion products was cracked off (pictures 11 and 12) also a sulphur concentration of more than 10% – besides a high content of oxygen and iron – could be determined (*Table 2, columns 5, 6*). It is not possible to determine by means of the results of the analysis in which chemical bound form the sulphur is present. The source for the sulphur contamination cannot be stated. Based on the analysis of the attached paint remains the coating can be excluded as the source of the sulphur supply.

Bild 11 REM-Aufnahme der Bruchfläche, Probe 1.3/00/3664 V021

Bild 12 REM-Aufnahme eines Bruchflächenbereichs mit partiell abgeplatzter Schicht der Korrosionsprodukte, Probe 1.3/00/3664 V011

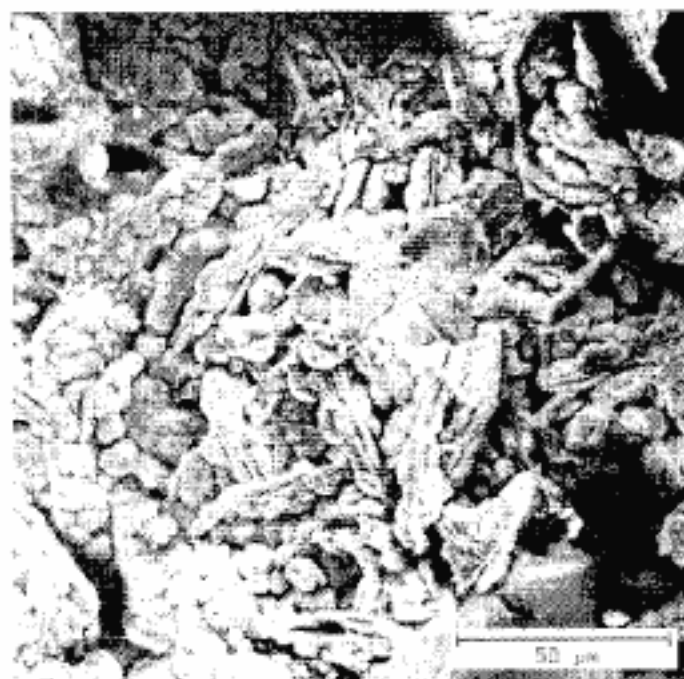
Picture 13 shows a fracture surface area with the layer of corrosion products having been more or less cracked-off (specimen 1.3/00/3664 VO11). The chemical composition of this fracture surface area is stated in *Table 3, column*

2. In the fracture surface area only to a small extent covered by corrosion products small quantities of nickel are present. Nickel as well as chrome and manganese could also be proved in those parts of the fracture surface (Table 3, column 3) where the thick layer of corrosion products had been removed mechanically (picture 14). While the manganese being an alloy part is present in non-alloyed building steels, the contents of nickel and chrome cannot be explained. On the SEM picture of this fracture surface area (picture 14) a crack is visible. It cannot be excluded that in addition to this fracture (through-running crack) further cracks (secondary cracks) do exist in the material.

Bild 13 REM-Aufnahme eines Bruchflächenbereichs mit vollständig abgeplatzter Schicht der Korrosionsprodukte, Probe 1.3/00/3664 V011

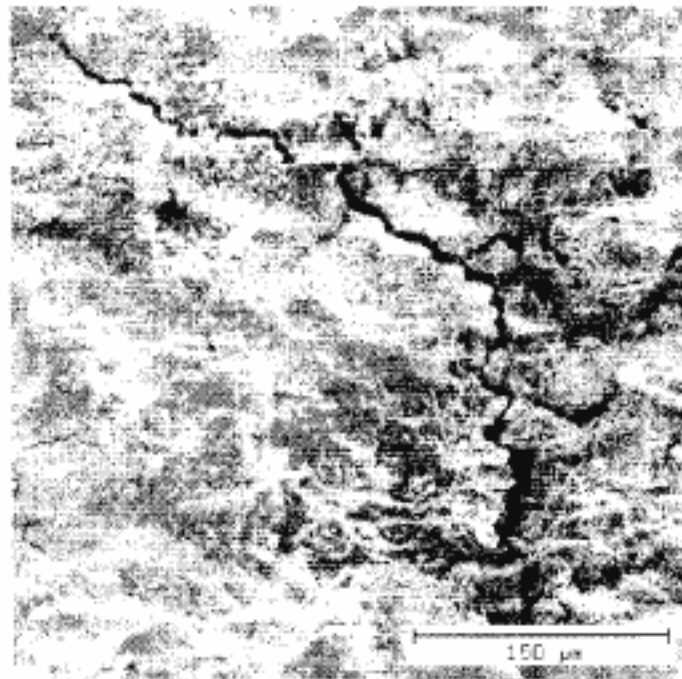
Bild 14 REM-Aufnahme eines Bruchflächenbereichs nach mechanischer Entfernung der Schicht der Korrosionsprodukte, Probe 1.3/00/3664 V011

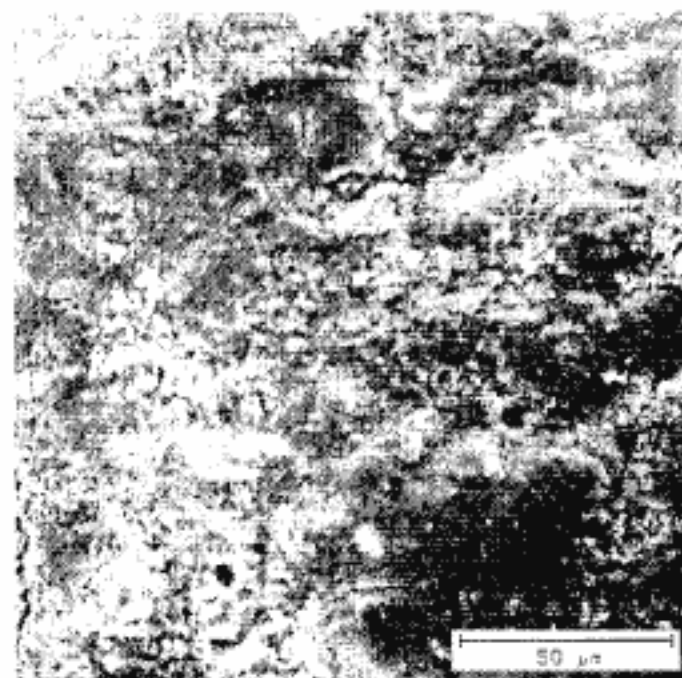
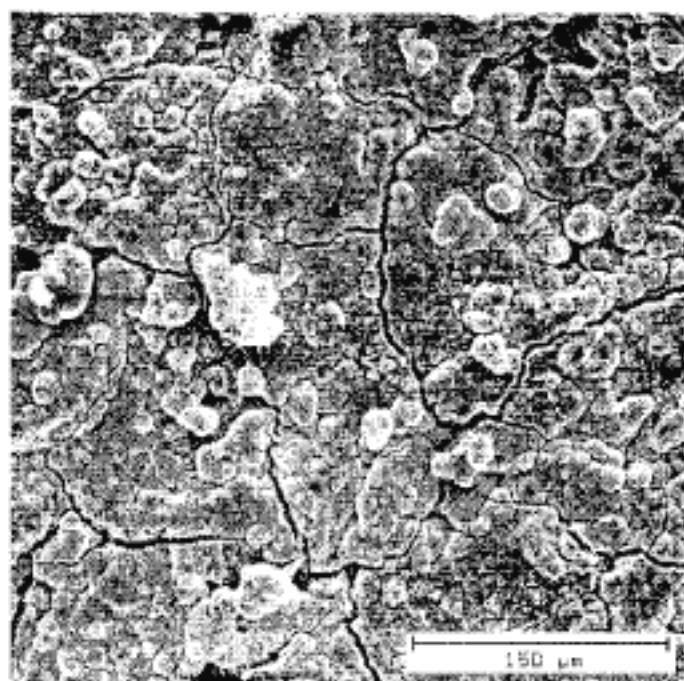
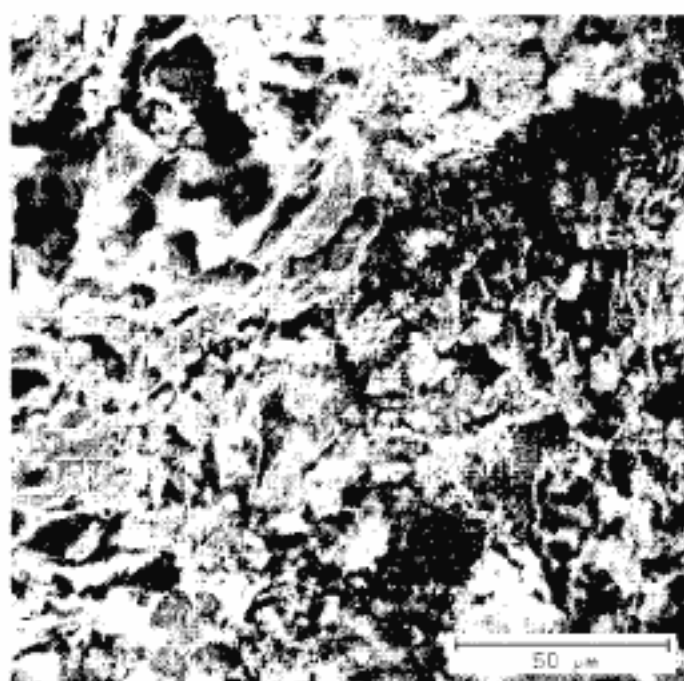
For the purpose of comparison areas of the inner surface near the fracture edge have been examined. Pictures 15-17 (specimen 1.3/00/3664 V021) show respective surface areas and their chemical composition is shown in columns 4

to 6 of *Table 3*. The appearance forms of the corroded areas of the inner surface are similar to those of the fracture surface. The surface area with completely attached corrosion layer consists mainly of the oxidizing products of iron (*Table 3, column 4*). Similar to the composition of the fracture surface (*Table 2, columns 2-4*) also at the inner surface increased concentrations of silicon and sulphur are present. Also at the areas of the inner surface, where the layer of corrosion products is partly cracked off, the composition of the respective areas complies with the fracture surface, i.e. also in areas of the inner surface a sulphur content of more than 10% has been established. In way of the area of the inner surface (picture 17) where the layer of corrosion products was mostly cracked off, the elements nickel (1.3%), copper (0.9%) and chromium (0.2%) could be proved. These elements are neither parts of the steel nor of the coating.

Bild 15 REM-Aufnahme eines Oberflächenbereichs nahe dem Bruch mit dicker Schicht der Korrosionsprodukte, Probe 1.3/00/3664 V021

Bild 16 REM-Aufnahme eines Oberflächenbereichs nahe dem Bruch mit partiell abgeplatzter Schicht der Korrosionsprodukte, Probe 1.3/00/3664 V021

Bild 17 REM-Aufnahme eines Oberflächenbereichs nahe dem Bruch mit vollständig abgeplatzter Schicht der Korrosionsprodukte, Probe 1.3/00/3664 V021

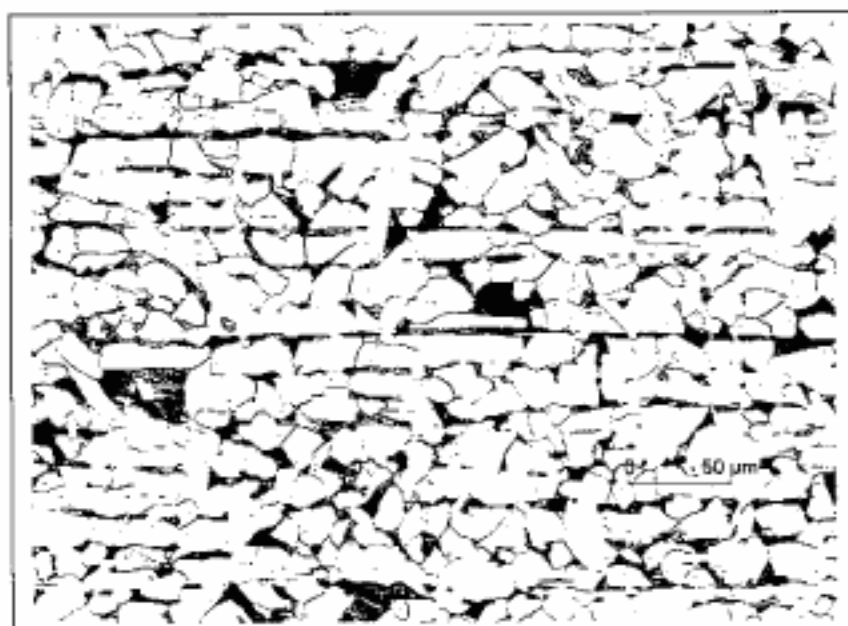
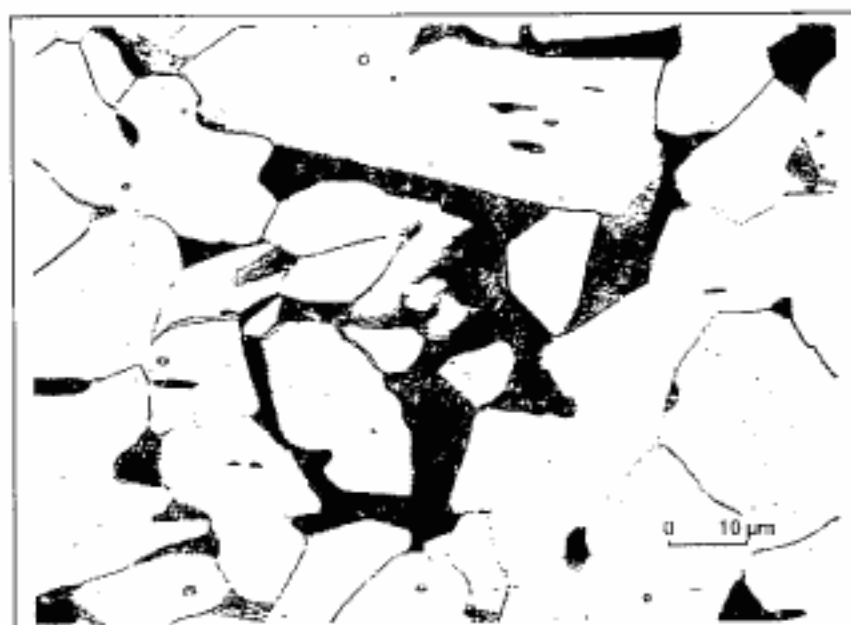
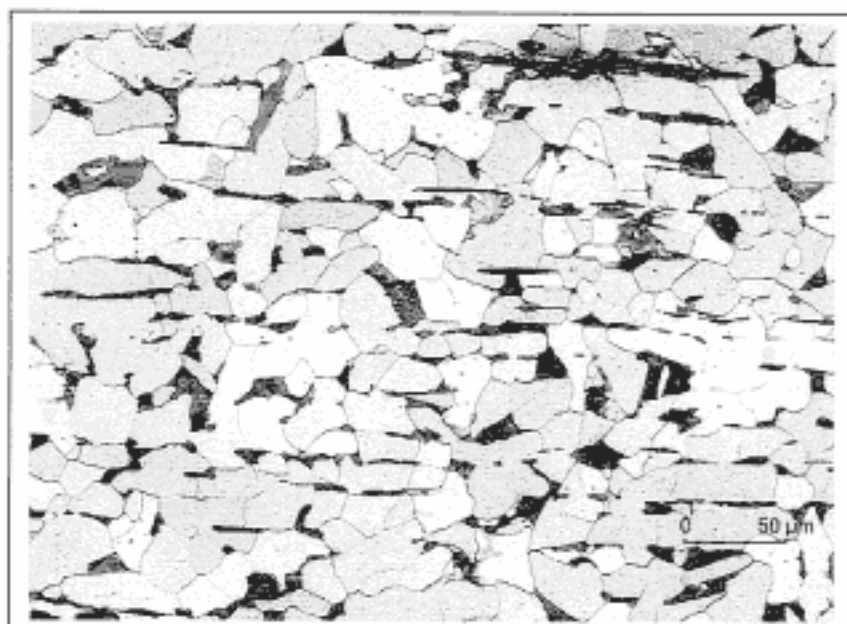
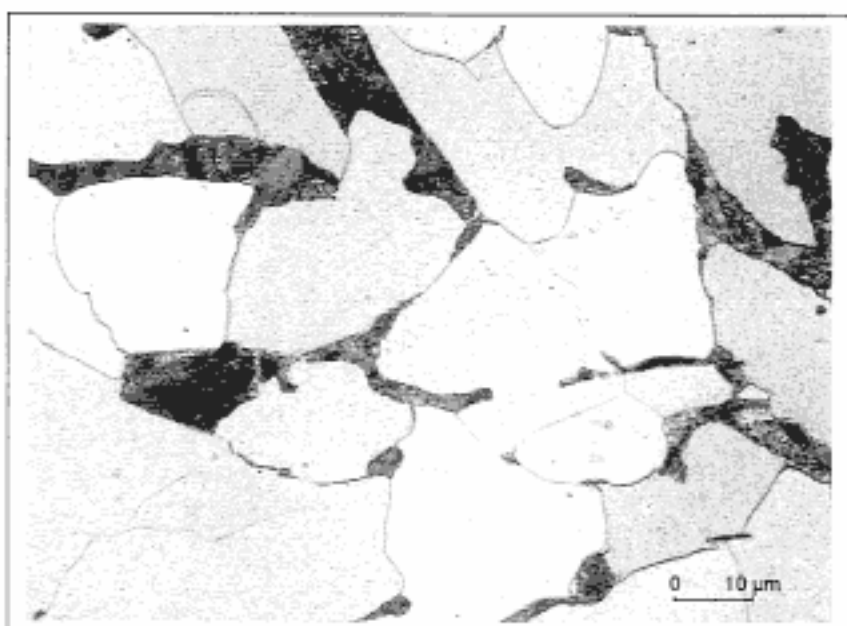
The metallographic examinations of specimen 13/00/3664 G011 and 13/00/3664 G012 revealed a fine, recrystallized, slightly lammellar ferrite, perlite structure with manganese sulphide slag and secondary cementite precipitations along the grain edges. The structure mainly consists of ferrite.

The perlite is structured fine to middle lamellar and built up distinctly lamellar. The light microscope examination did not reveal any changes by eventual mechanical influences (pictures 18-21). This structural condition can be compared with the structure of a finely granular non-alloyed building steel.

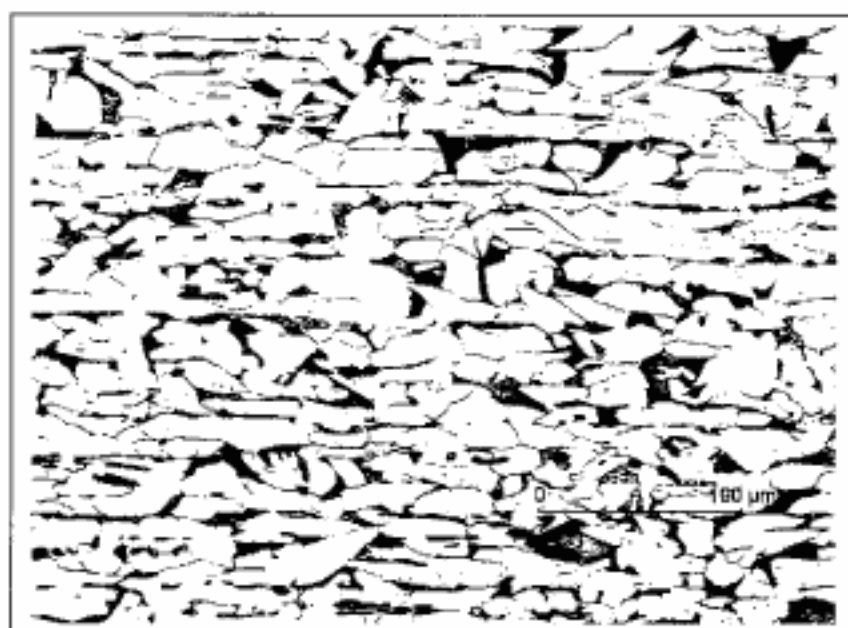
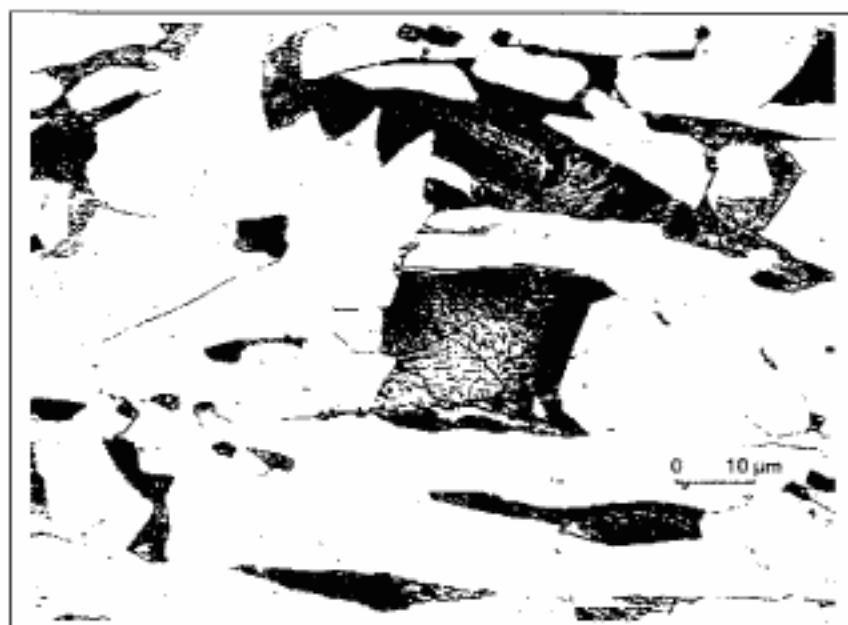
The structure of specimen 13/00/3664 G021, which had been taken ca. 1 cm off the fracture edge (turned 90° as to specimen 13/00/3664 G022), shows only minor changes (picture 22, 23), as for example slight changes in the perlite grain (picture 23), which is partly still granular and partly a destruction of the lamellae in the grain is visible. The grain is compared to the grain of specimens 13/00/3664 G011 and 13/00/3664 G012 slightly stretched (picture 22).

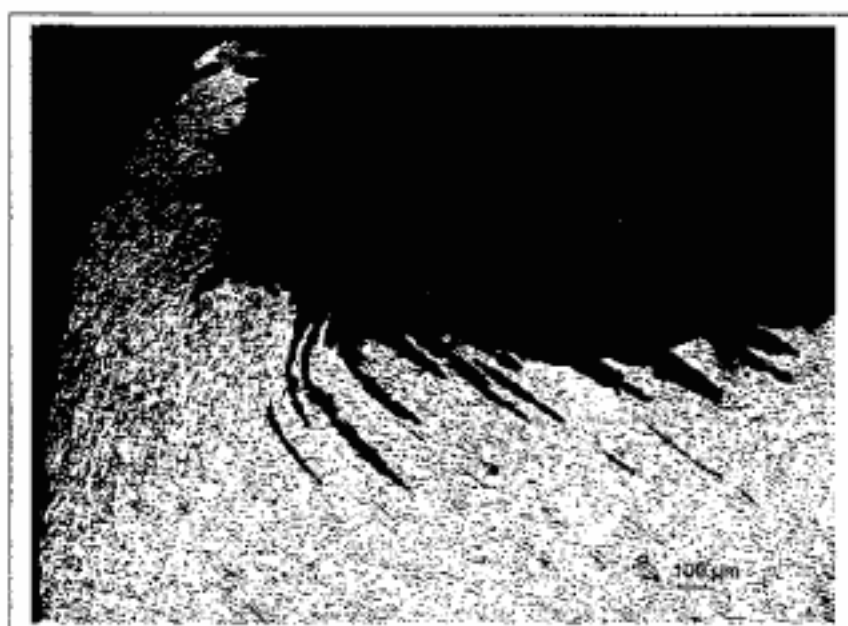
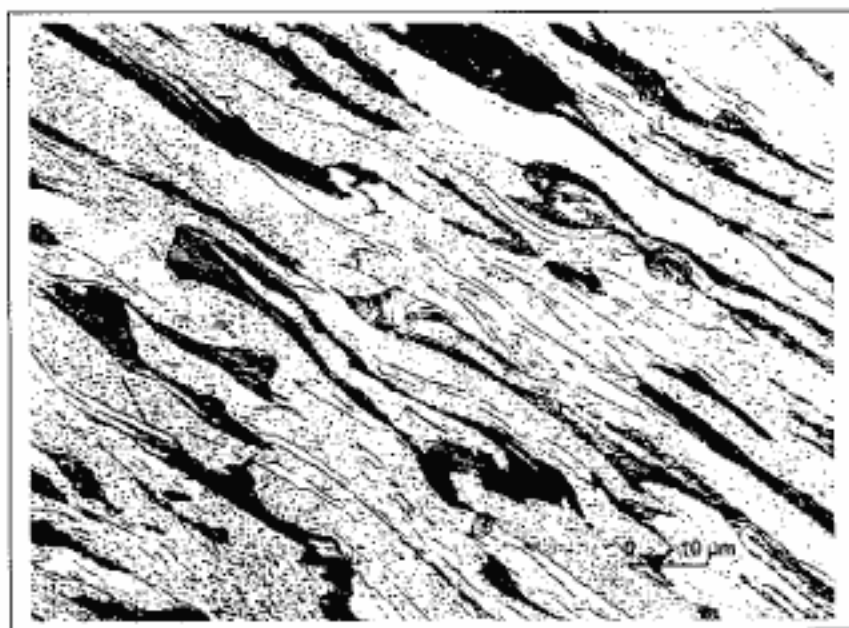
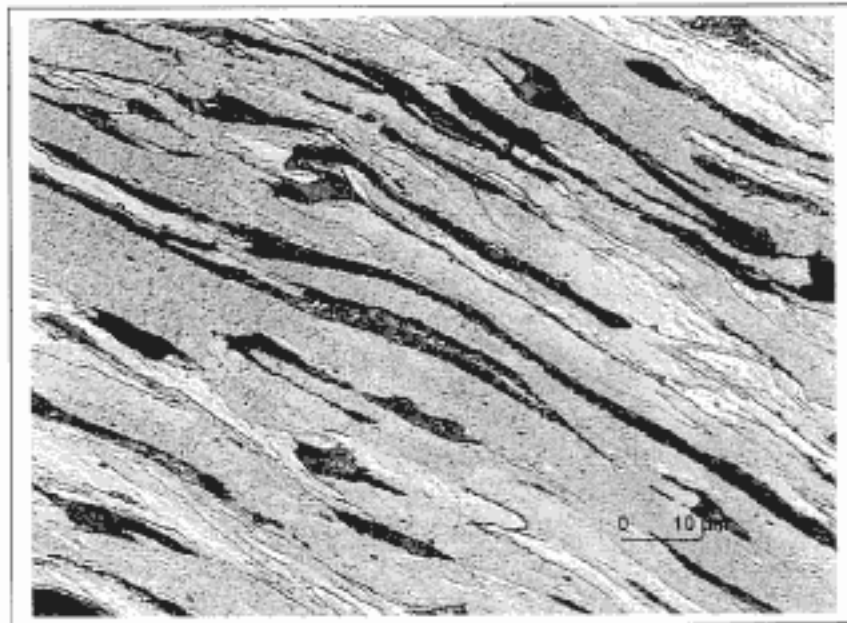
The structure of specimen 13/00/3664 G022 shows significant changes in way of the fracture edge area (pictures 26-33). These plastic deformations in the micro range do indicate exposure to extremely heavy shock forces such as happens from the effects of a substance detonating.

The resulting heat, which is created during such a shock by the internal friction whilst overcoming the sliding resistance, is responsible for the changes within the structure. Since the sliding does not occur in phases but undulatively (as a consequence of the movements of displacements), this is also recognizable as undulative formation of the structural parts (pictures 26-33). The shearing bands created are in particular clearly visible on the pictures 27 and 28. The initial structural parts are extensively destroyed. On the overview of the micro section of specimen 13/00/3664 G022, pictures 24 and 25, the undulative condition of the structural parts is recognizable also in the macro range. The undulative condition of the fracture edge is located at the inside of the bulkhead.

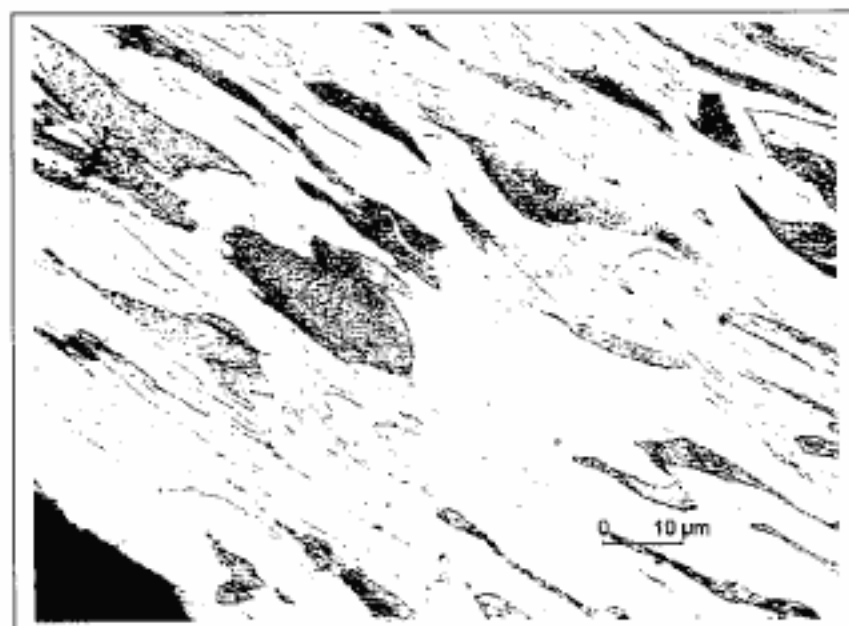
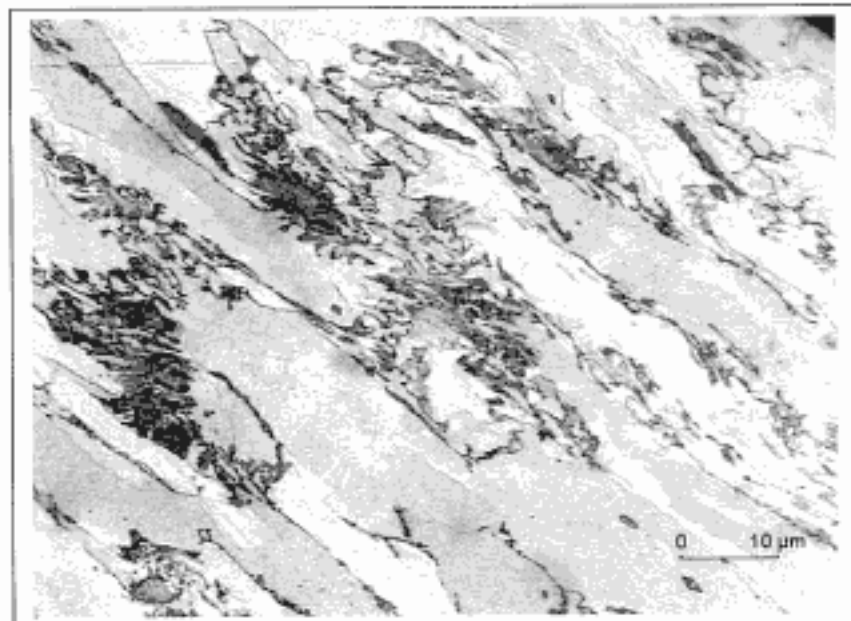
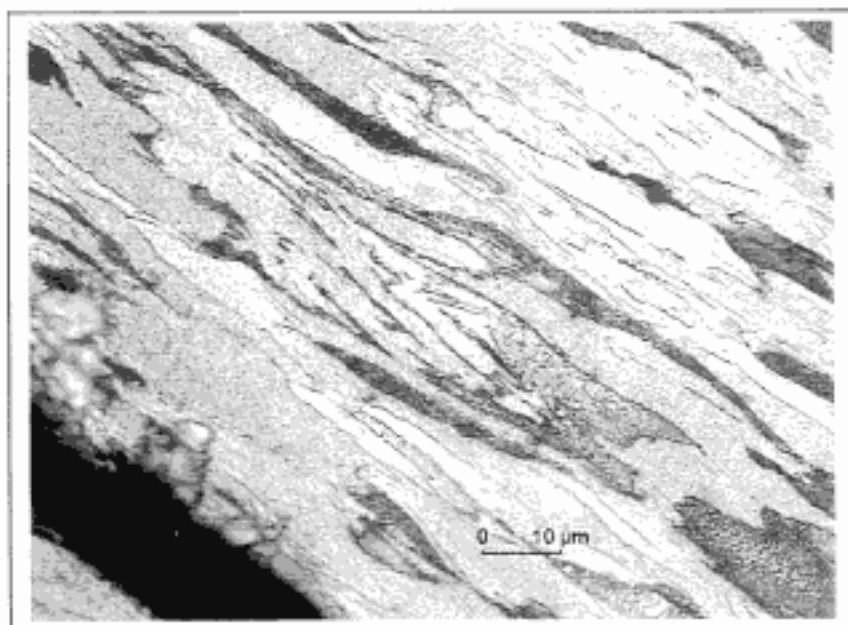
The in volume panel-shaped iron carbide parts of the perlite are unable to resist the strong micro processes. The destruction of this perlite, marked on the micro section as lamellar structure, becomes particularly clear on pictures 29, 31 and 33. A destruction of the lamellae has occurred which cannot occur by any comparable mechanical technological influence. The processes of explosive treatments of metallic materials as for example explosive hardening and explosive cladding have to be excluded. These processes show in surface-near areas comparable effects.

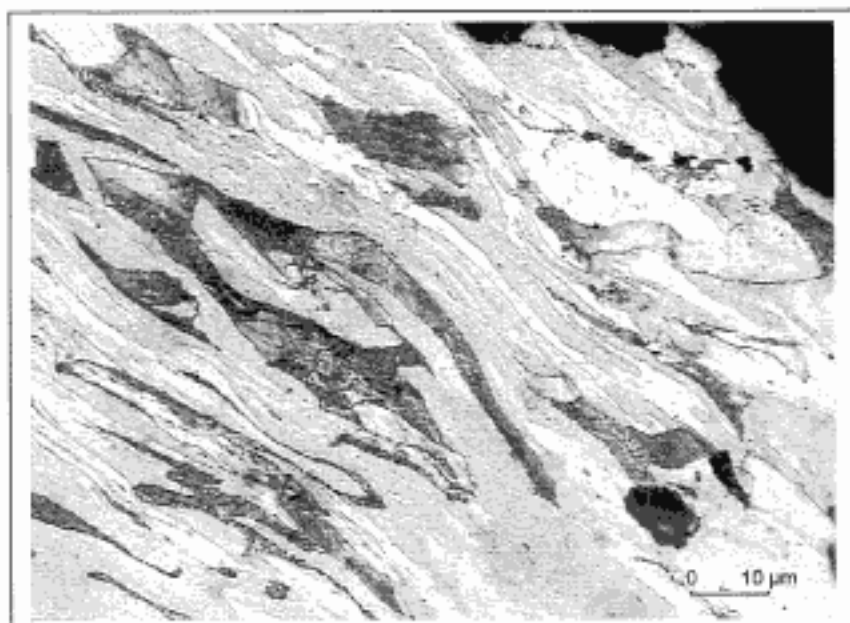
Bild 32 Probe 1.3/00/3664 G02 2

Whether the jagged lines on the right hand side of picture 32 indicate internal cracks has to be established by further examinations.

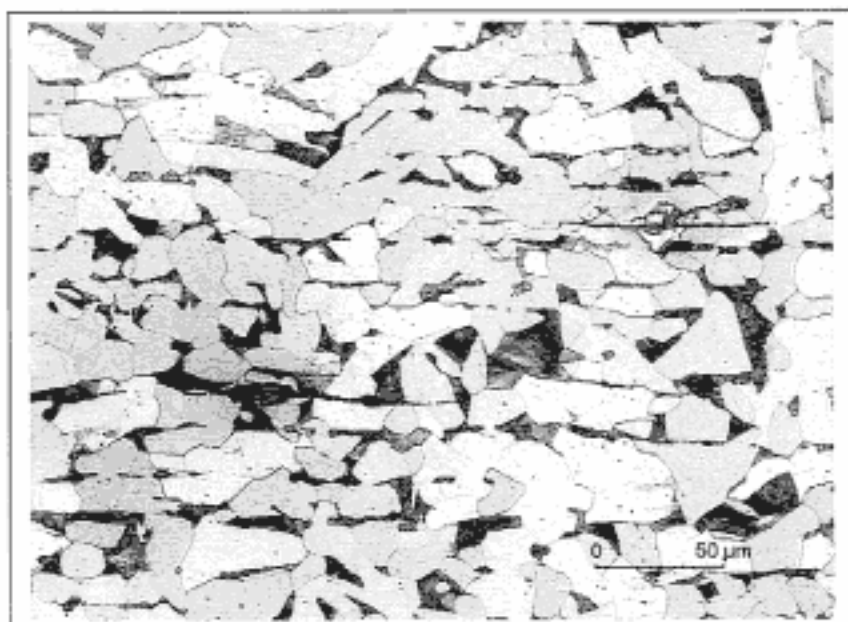
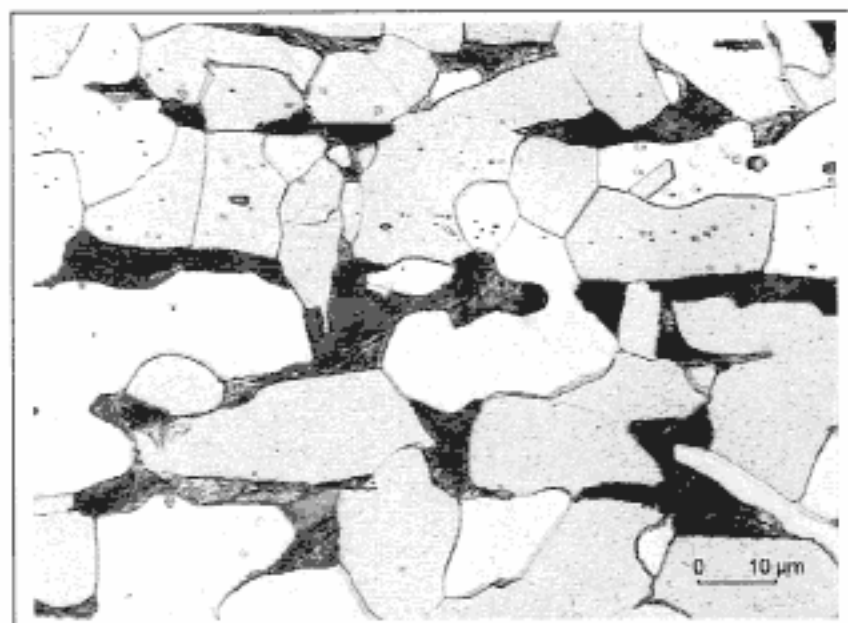
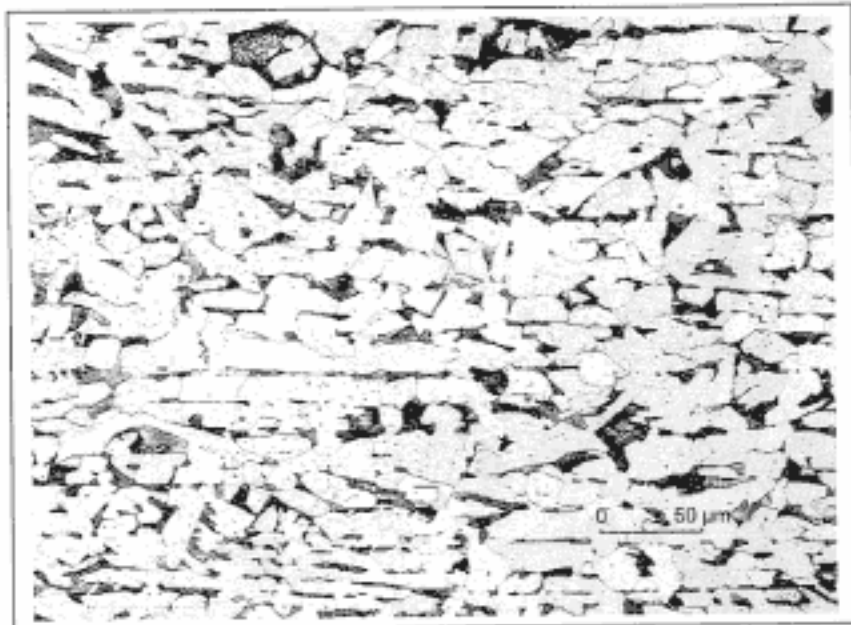
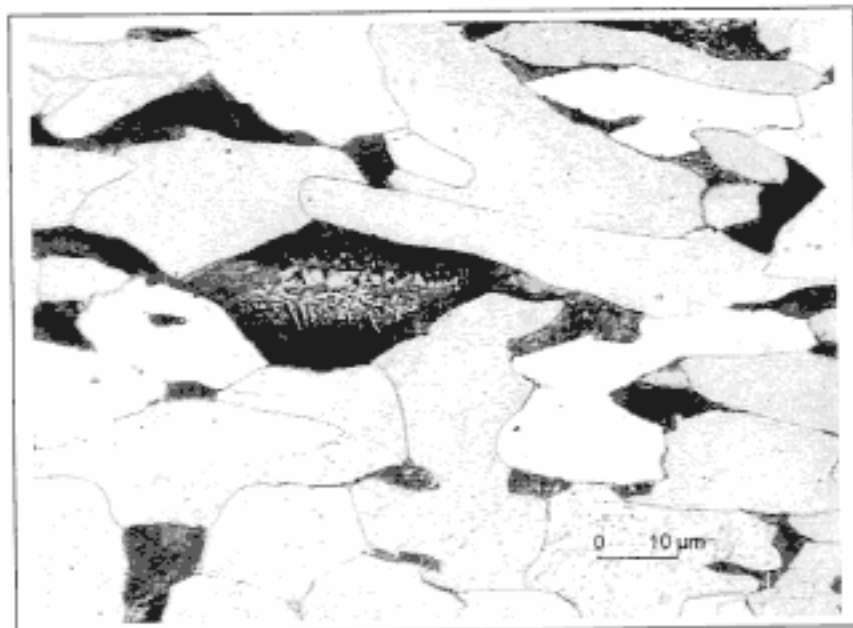
The structures of specimen 13/00/3664 G031 (pictures 34-37) also show only minor changes, comparable to those of specimen 13/00/3664 G021, which is primarily recognizable by a change of the perlite grain (picture 35).

Also here it is established that there are slight changes in the perlite grain (pictures 35, 37), which partly is still lamellar and which partly shows a destruction of the lamellae in the grain. Stretching of the grains in comparison to the grains of the specimen 13/00/3664 G011 and 13/00/3664 G012 is hardly visible (picture 22).
