**Material Testing Laboratory  
of the State of Brandenburg -**

**Examination Report**

No. 1.1/00/3669

Contents Material examination of a part of the starboard front bulkhead  
of the ferry "Estonia" in order to prove mechanically caused  
structure deformations additional examinations as to order  
1.3/00/3664.

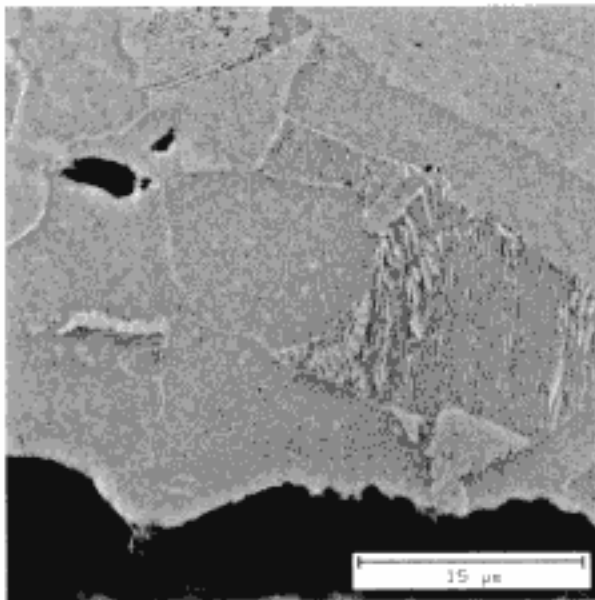
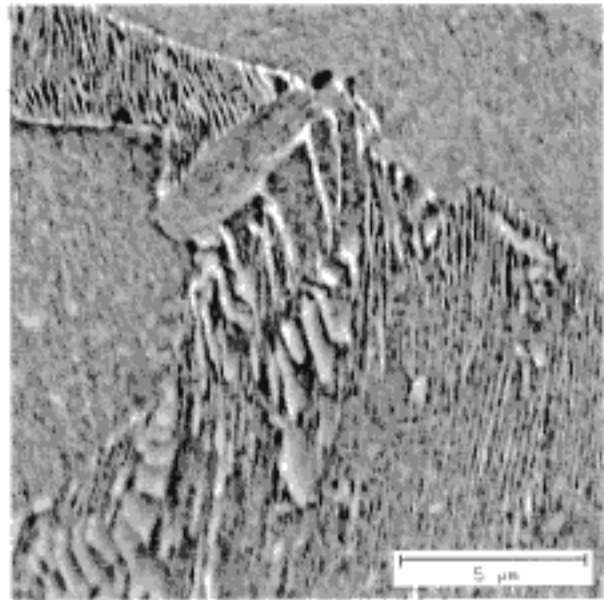
Beside the areas with still distinct lamellar structure of the cementite lamellas  
(pictures 2 and 3) there are areas with severely deformed lamellas (picture 4  
and 5) respectively with destroyed lamellas (pictures 4 to 7). The typical

Bild 2 REM-Aufnahme der metallographisch bearbeiteten Fläche - Perlitkorn

Bild 3 REM-Aufnahme der metallographisch bearbeiteten Fläche - Perlitkorn; Detail von Bild 2

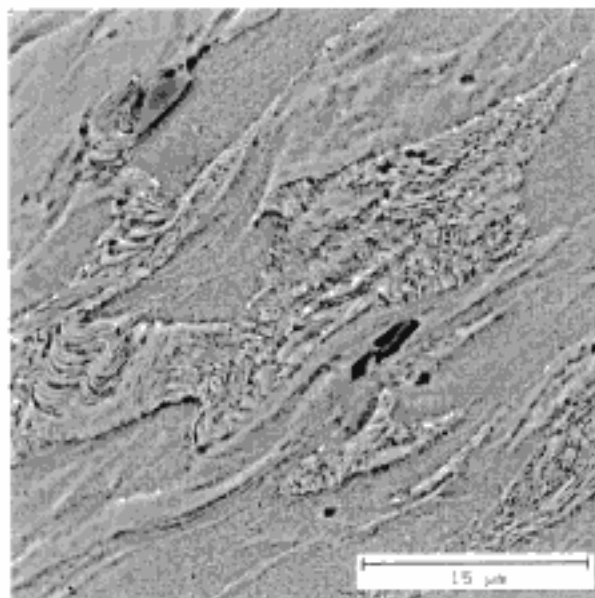
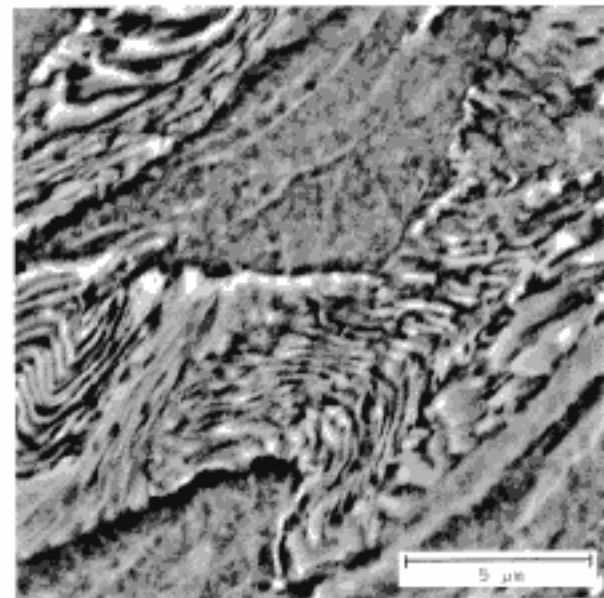
rounded grain form of perlite is most extensively changed respectively does no more exist.

Bild 4 REM-Aufnahme der metallographisch bearbeiteten Fläche - Perlitkörner

Bild 5 REM-Aufnahme der metallographisch bearbeiteten Fläche - Perlitkörner; Detail von Bild 4

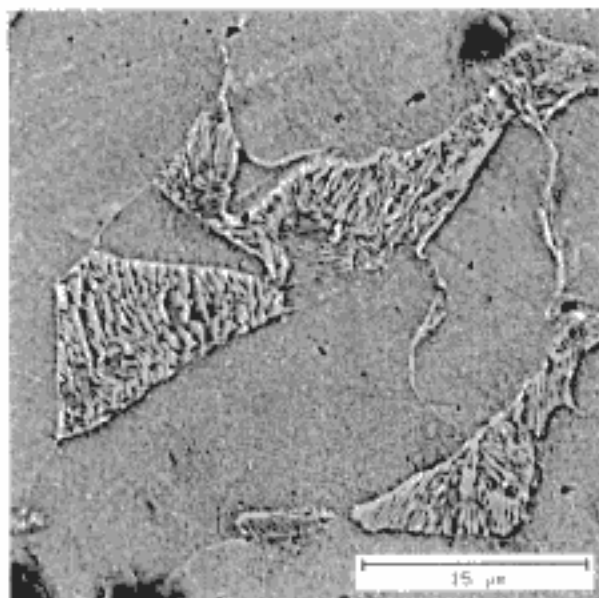
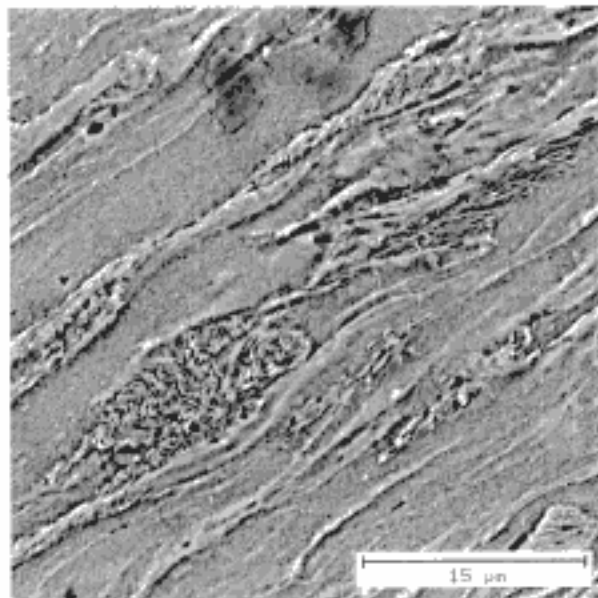
The results correlate with the metallographic examinations of specimen GO 22 of order 1.3/00/3664. These plastic deformations in the micro area do indicate an extreme striking strain, as occurs in a detonation.

Bild 6 REM-Aufnahme der metallographisch bearbeiteten Fläche - Perlitkörner

Bild 7 REM-Aufnahme der metallographisch bearbeiteten Fläche - Perlitkörner gerissen

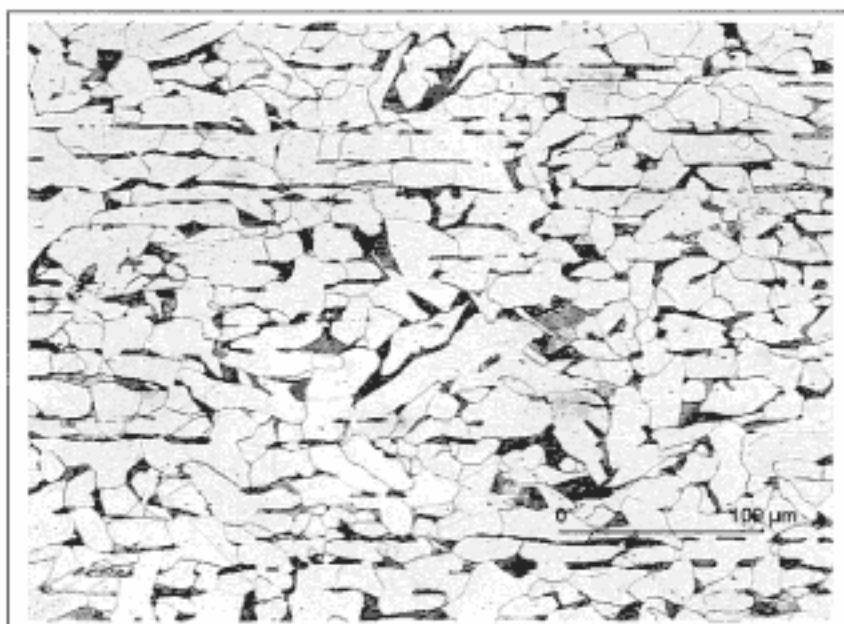
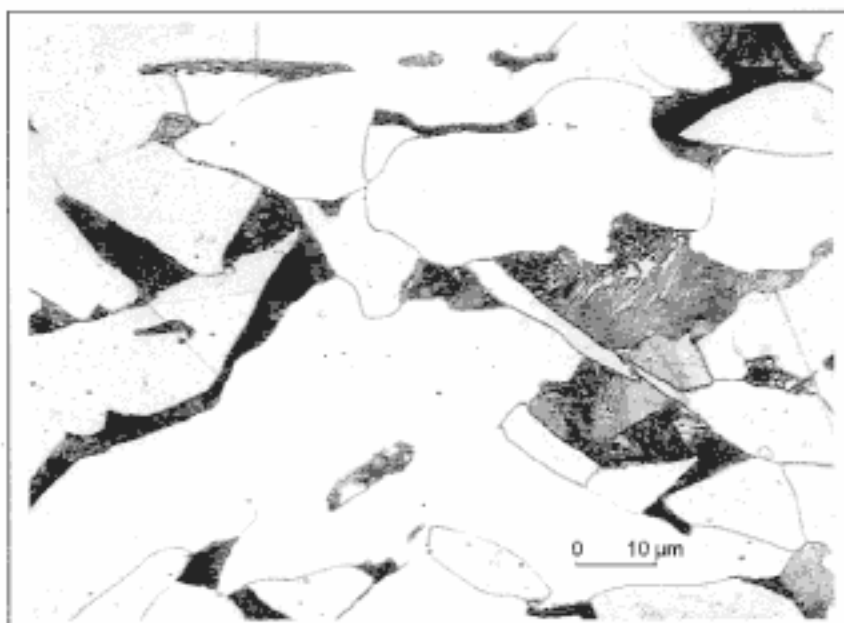
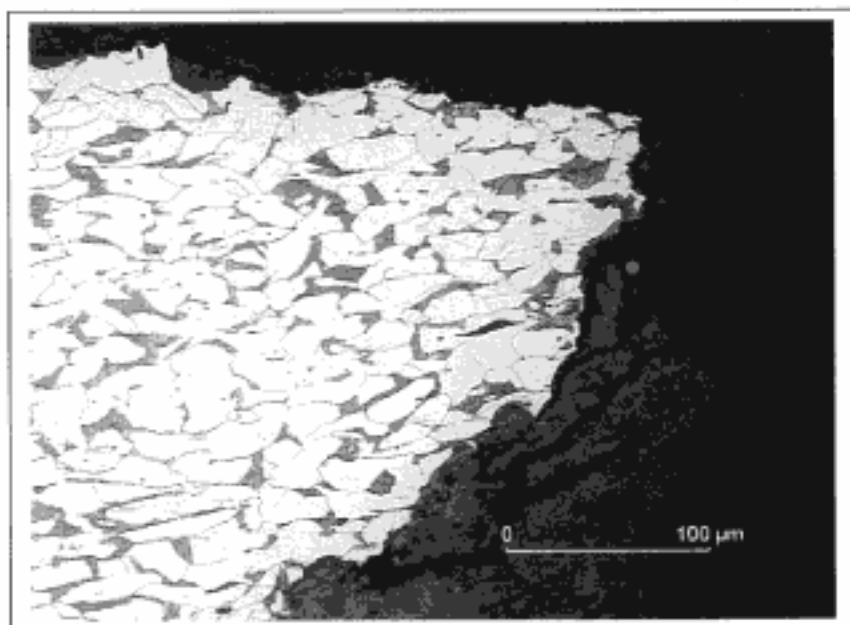
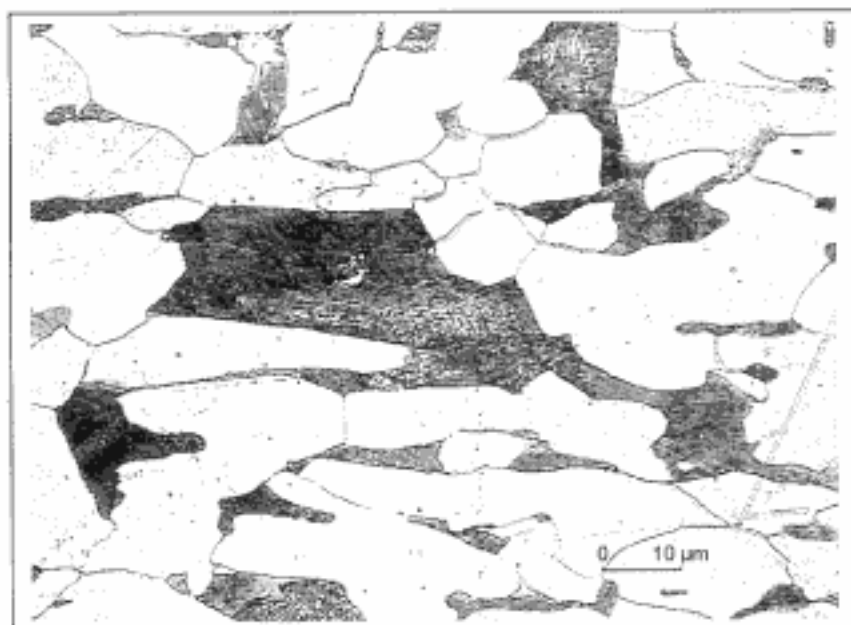
The metallographic examination of specimen 1.1/00/3669 GO11 and 1.1/00/3669 GO12 (picture 1, sample cut no. 4) show a fine, recrystallined, slightly lamellar ferrite, perlite structure with manganese sulphide slag and secondary cementite precipitations along the grain edges (pictures 8-11). The structure mainly consists of ferrite. Inside the perlite grain changes of the cementite lamellars are visible. The striped lamellar structure is clearly disturbed (pictures 9, 11). On examining specimen 1.1/00/3669 GO21 and

Bild 8 Probe 1.1/00/3669 G011  
Probenplan Nr.: 4

Bild 9 Probe 1.1/00/3669 G011  
Ausschnitt aus Bild 8

Bild 10      Probe 1.1/00/3669 G012  
Probenplan Nr.: 4

Bild 11      Probe 1.1/00/3669 G012  
Ausschnitt aus Bild 10

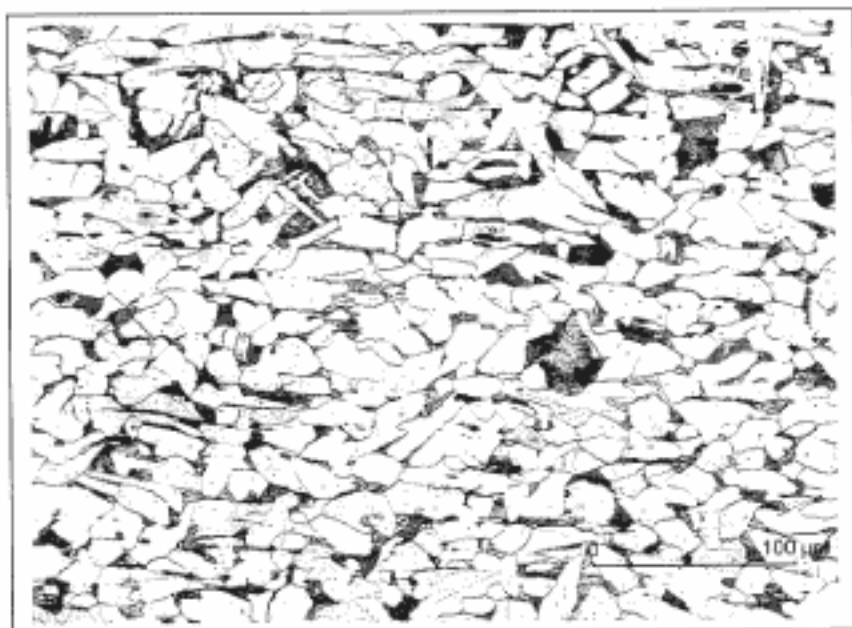
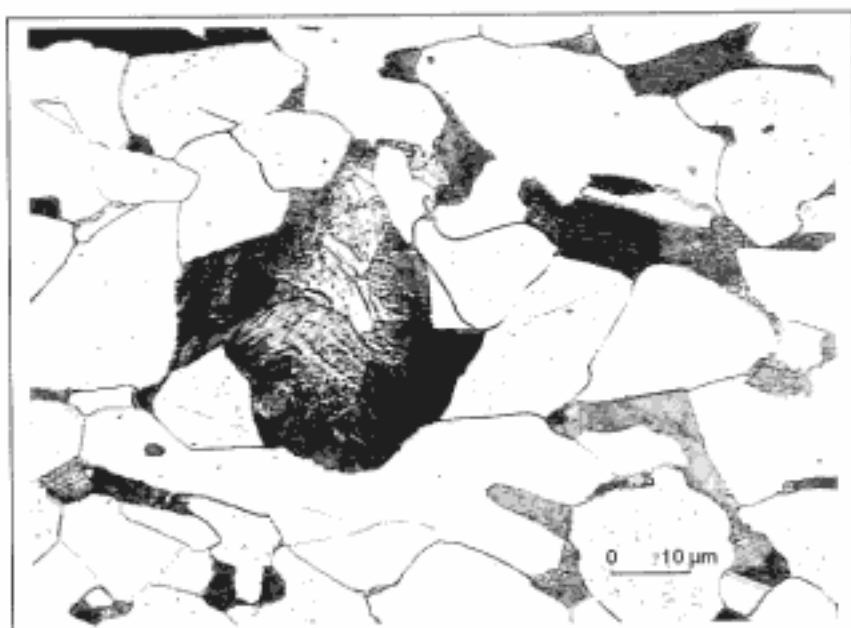
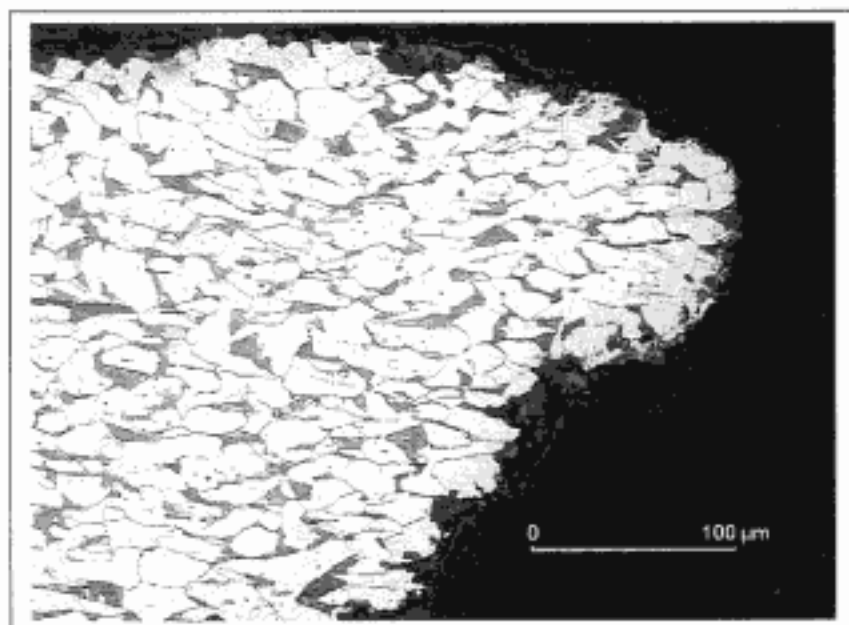
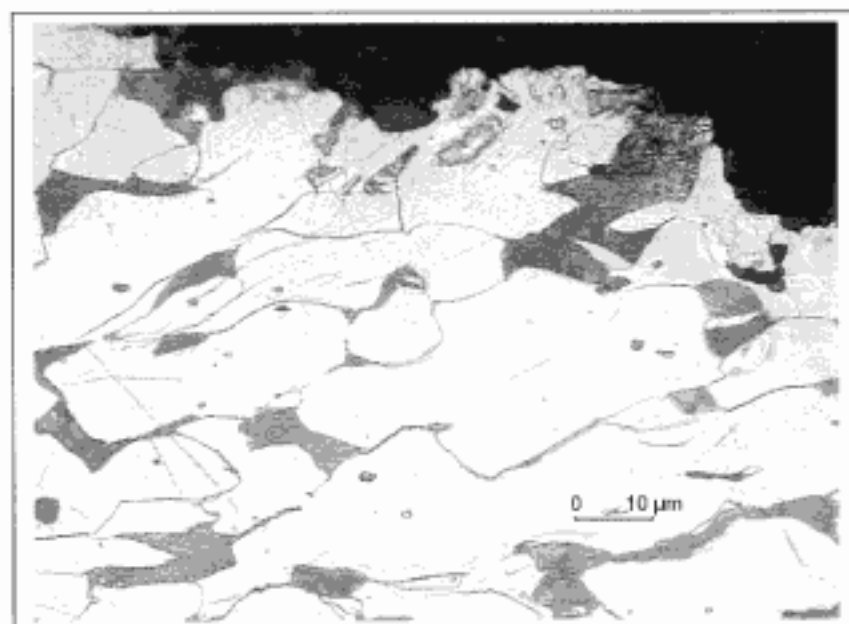
1.1/00/3669 GO22 (picture 1, sample cut 5) changes were recognized which indicate higher strain.

The systematic arrangement of the structural parts is changed (pictures 12-17). Inside the ferrite grain sliding planes and shear bands are visible (pictures 16, 17).

Bild 12 Probe 1.1/00/3669 G021  
Probenplan Nr.: 5

Bild 13 Probe 1.1/00/3669 G021  
Ausschnitt aus Bild 12

Bild 14 Probe 1.1 /00/3669 G022  
Probenplan Nr.: 5

Bild 15 Probe 1.1/00/3669 G022  
Ausschnitt aus Bild 14

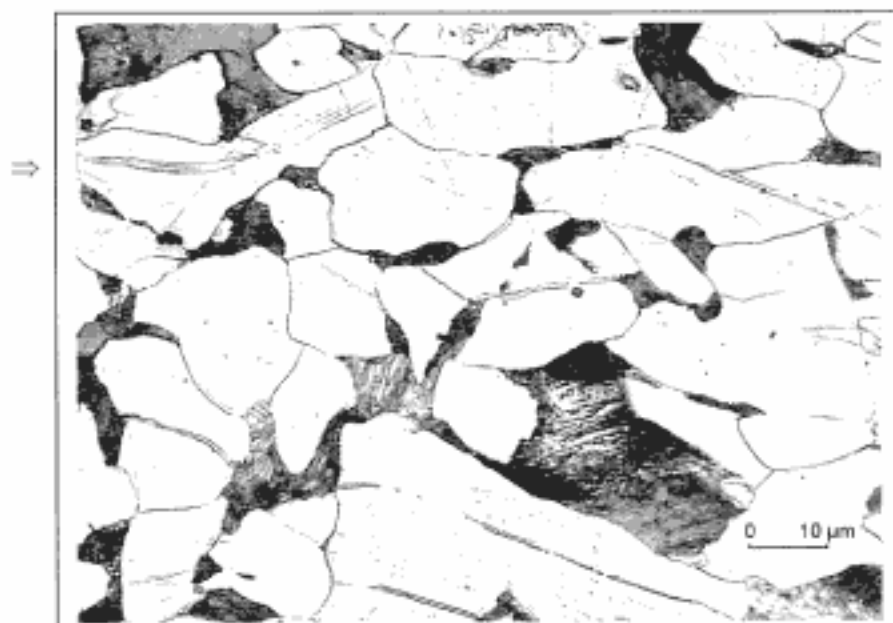
Bild 16     Probe 1.1/00/3669 G022  
Ausschnitt aus Bild 14  
⇒ Gleitebenen

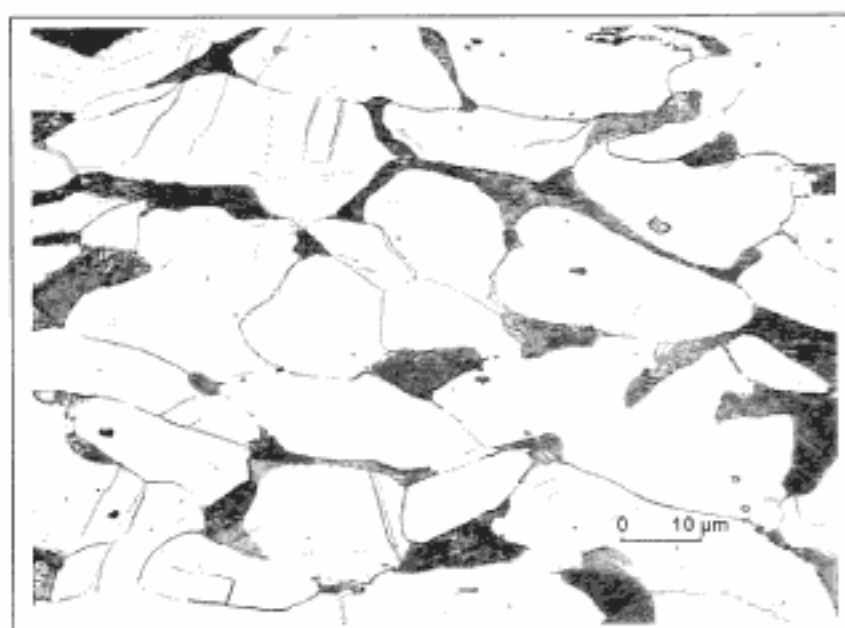
Bild 17     Probe 1.1 /00/3669 G022  
Ausschnitt aus Bild 14  
⇒ Scherbänder

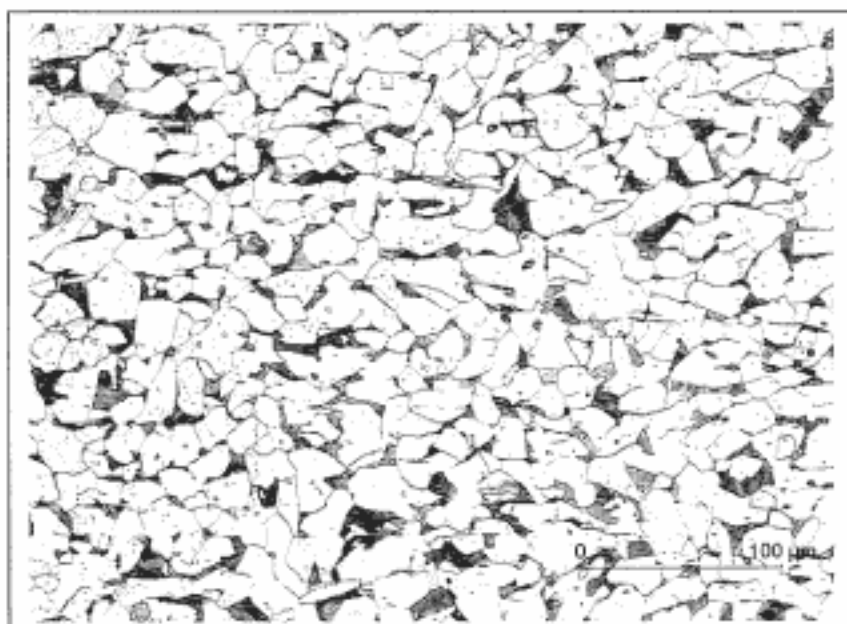
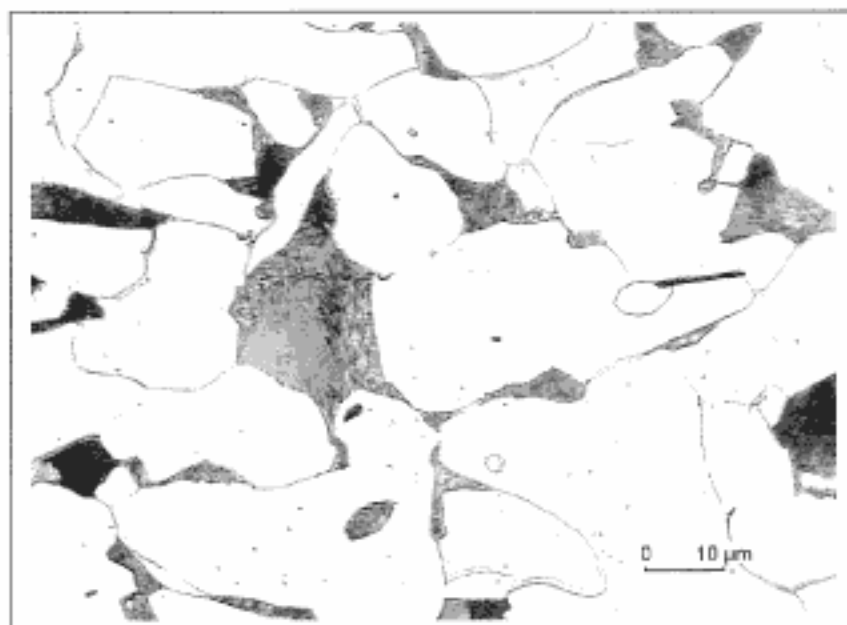
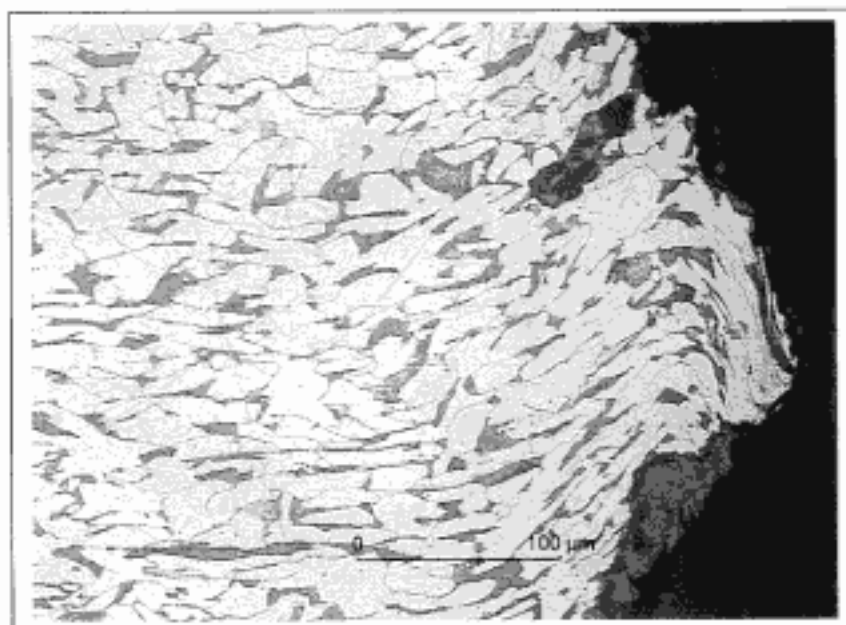
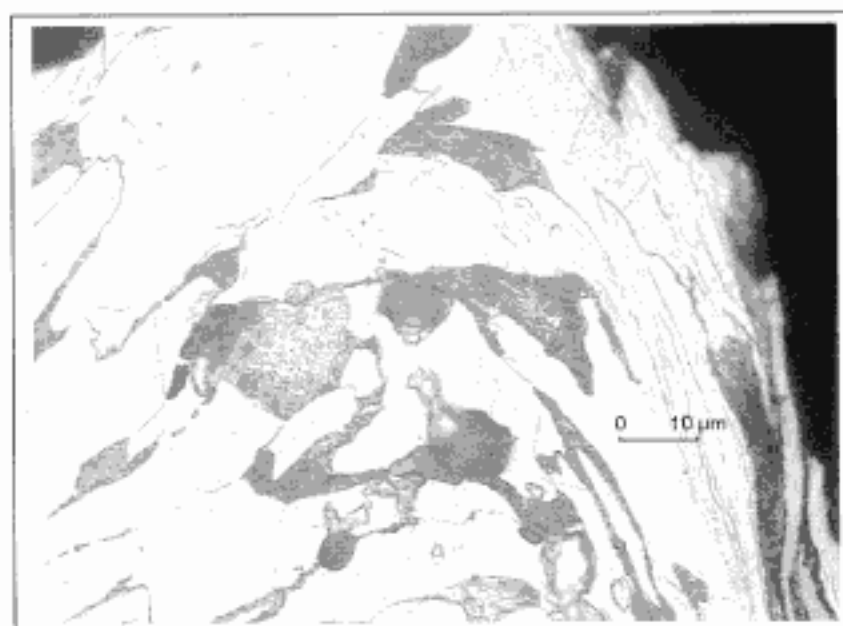
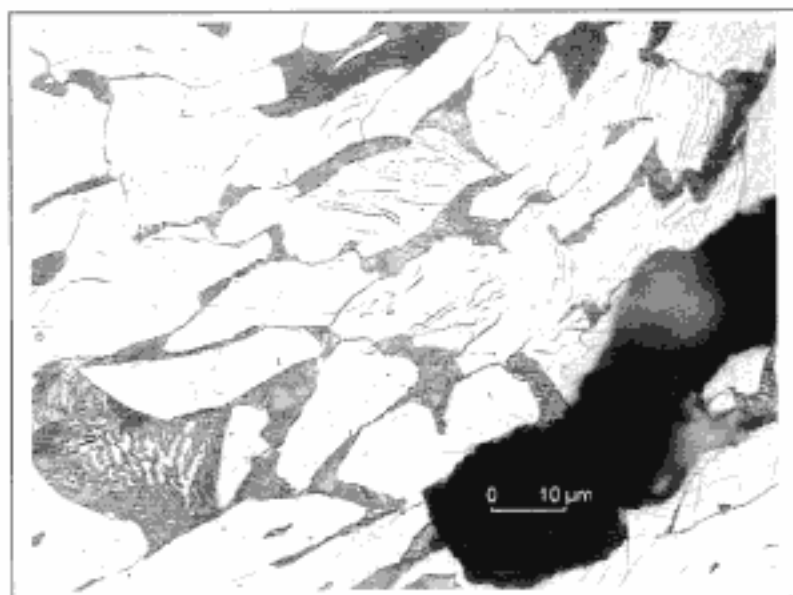
These changes can also be seen on specimen 1.1/00/3669 GO31 and 1.1/00/3669 GO32 (picture 1, cut sample no. 7), 1.1/00/3669 GO41 and 1.1/00/3669 GO42 (picture 1, cut sample no. 8 – pictures 18-26). The disturbed lamellar arrangement of the perlite grains, as well as the existence of sliding planes and parallel shear bands, lead to the conclusion that there must have been stronger mechanical strain at a very high deformation velocity, which is typical for detonations (pictures 19, 21, 22, 24, 26).

Bild 18 Probe 1.1/00/3669 G031  
Probenplan Nr.: 7

Bild 19 Probe 1.1/00/3669 G031  
Ausschnitt aus Bild 18

Bild 20 Probe 1.1/00/3669 G032  
Probenplan Nr.: 7

Bild 21 Probe 1.1/00/3669 G032  
Ausschnitt aus Bild 20  
⇒ Gleitebenen

Bild 22      Probe 1.1/00/3669 G032  
Ausschnitt aus Bild 20  
Scherbänder

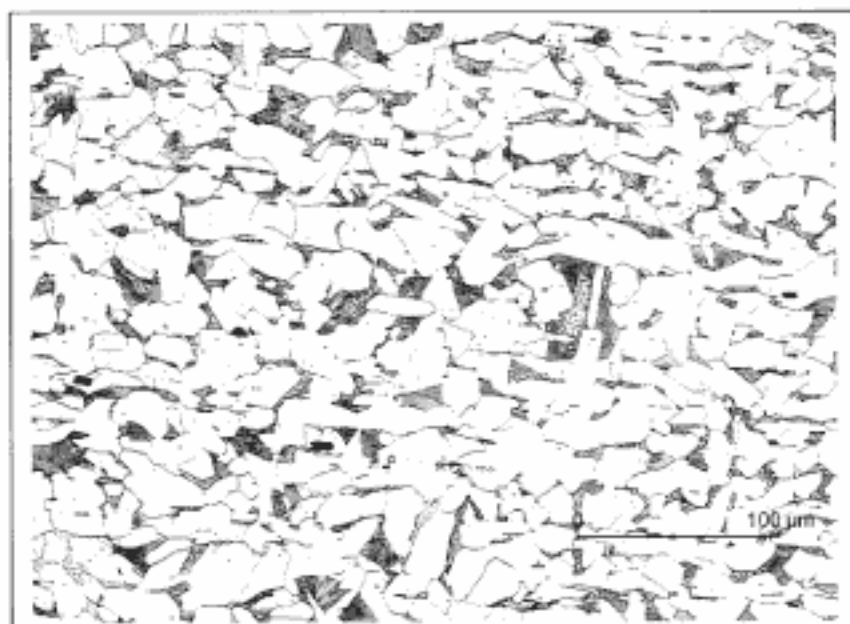
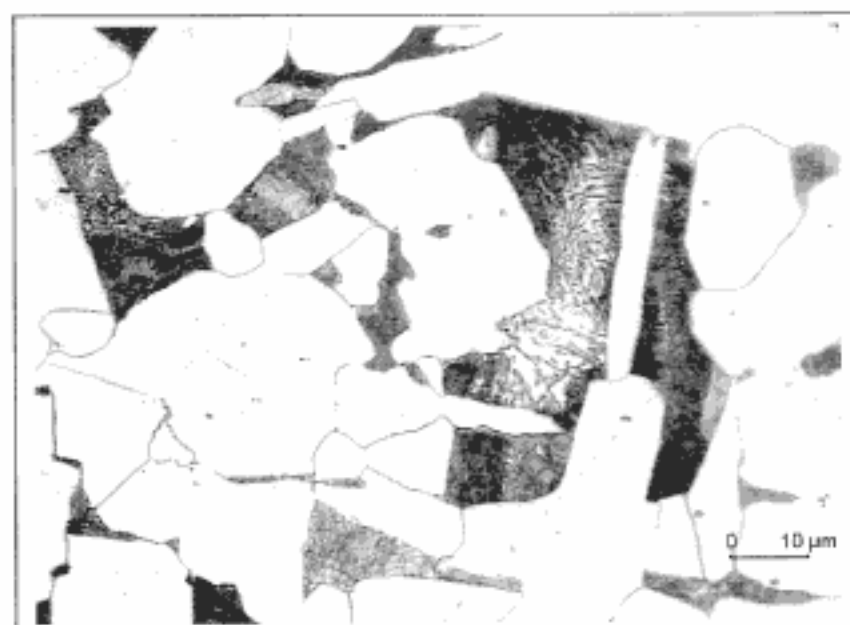
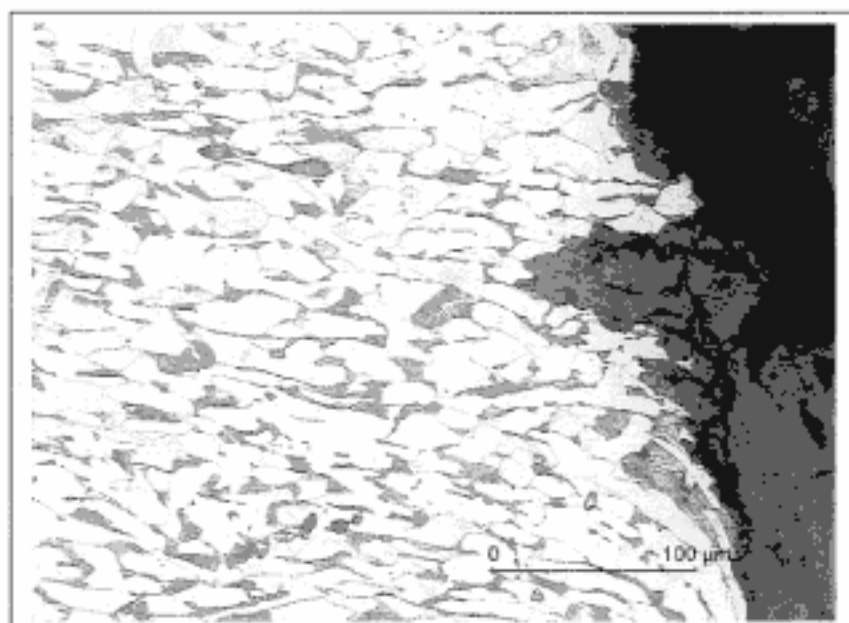
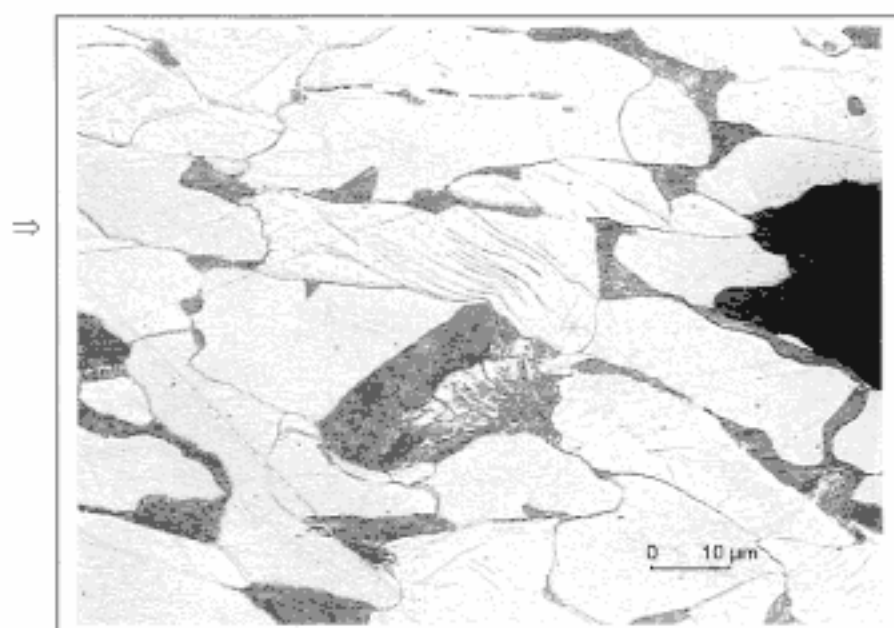
Bild 23      Probe 1.1/00/3669 G041  
Probenplan Nr.: 8

Bild 24      Probe 1.1/00/3669 G041  
Ausschnitt aus Bild 23

Bild 25      Probe 1.1/00/3669 G042  
Probenplan Nr.: 8

Bild 26      Probe 1.1/00/3669 G042  
Ausschnitt aus Bild 26  
⇒ Gleitebenen
