Mechanical and Materials Engineering Division
January 26, 2001

Subject: *Southwest Research Institute Project No. 18.04042.01.109*
“Examination of Metal Samples for Evidence of Shock Loading”
Final Report

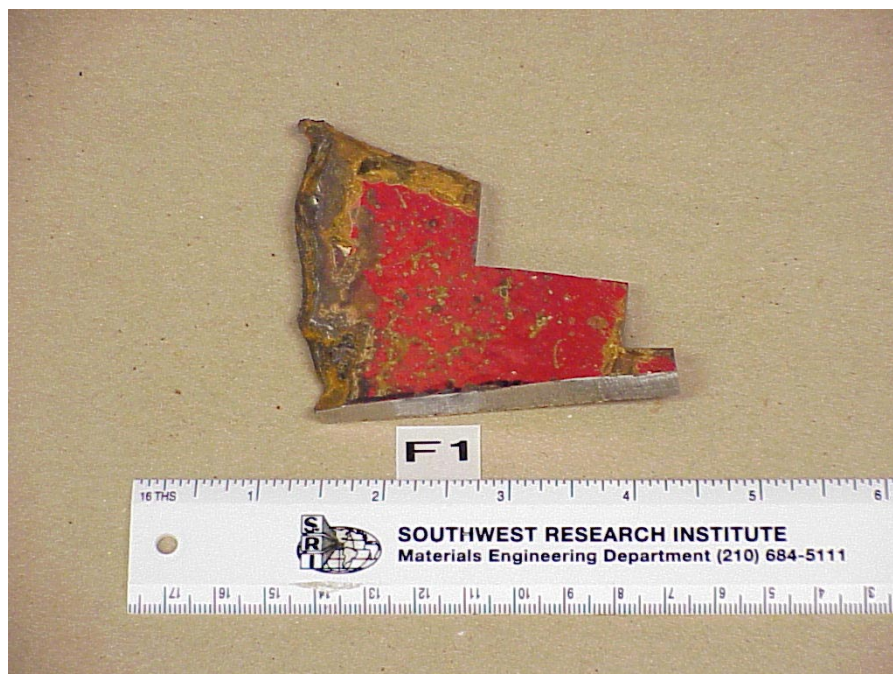
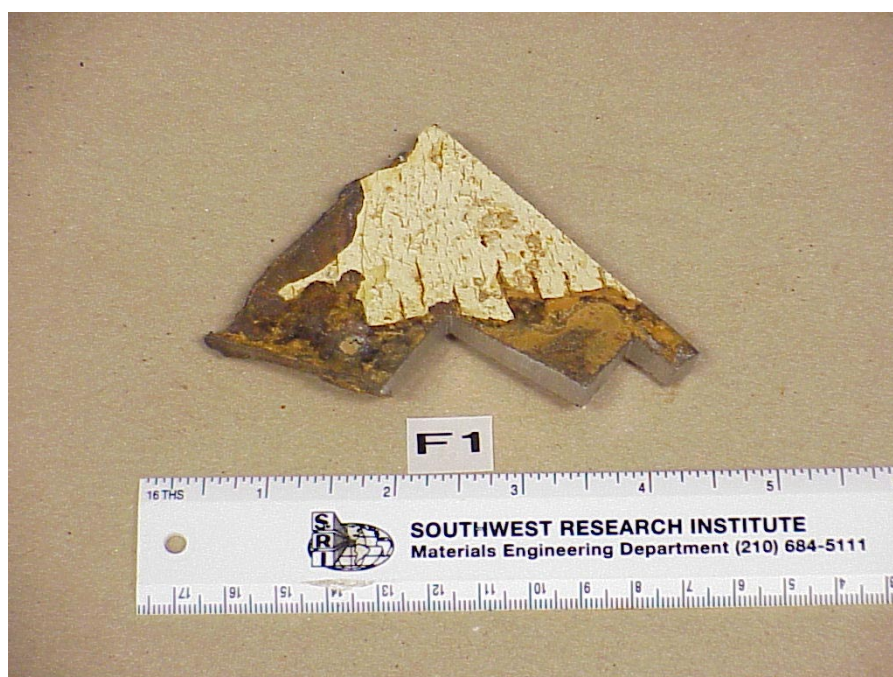
Figure 1. Overall views of both sides of Sample F1.

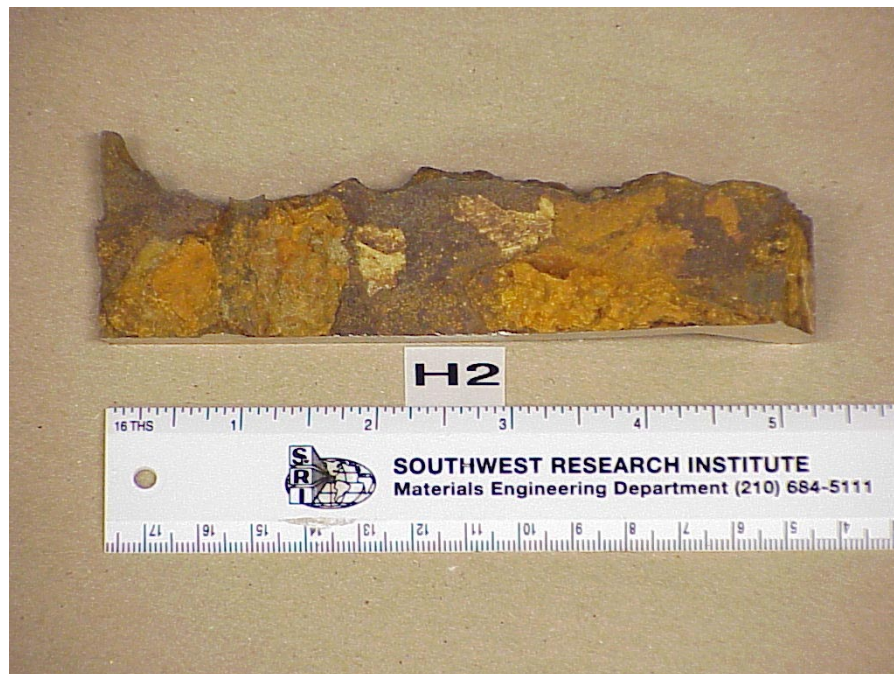
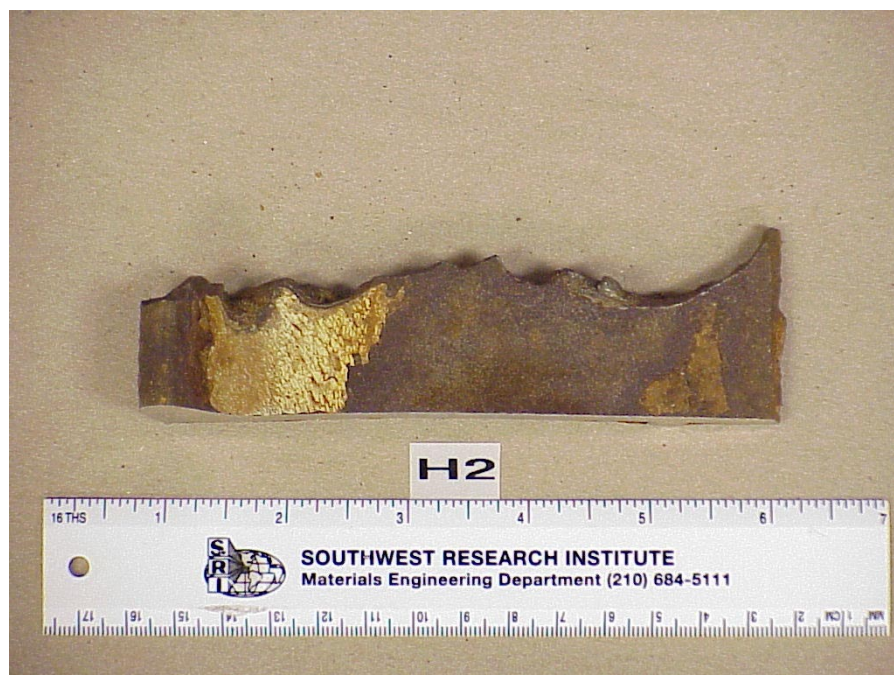
Figure 2. Overall views of both sides of Sample H2.

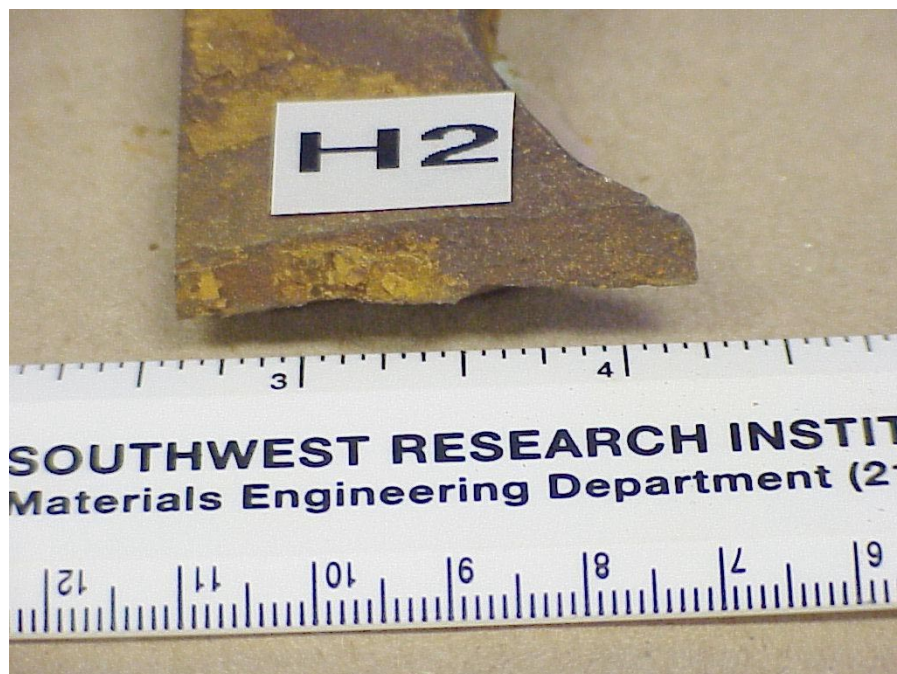
After cathodic cleaning to remove corrosion products from the fracture surface of Sample H2 (Figure 3), we attempted a direct evaluation of the fracture mechanism by scanning electron microscopy (SEM). This examination proved unfruitful, since the topographic details of the original fracture surface were almost completely corroded away. Nevertheless, the angled geometry of both fracture surfaces, combined with subsequent metallographic observations, clearly indicated fracture by a shearing mechanism due to tensile overload.

Figure 3. Fracture surface of Sample H2 prior to cathodic cleaning.

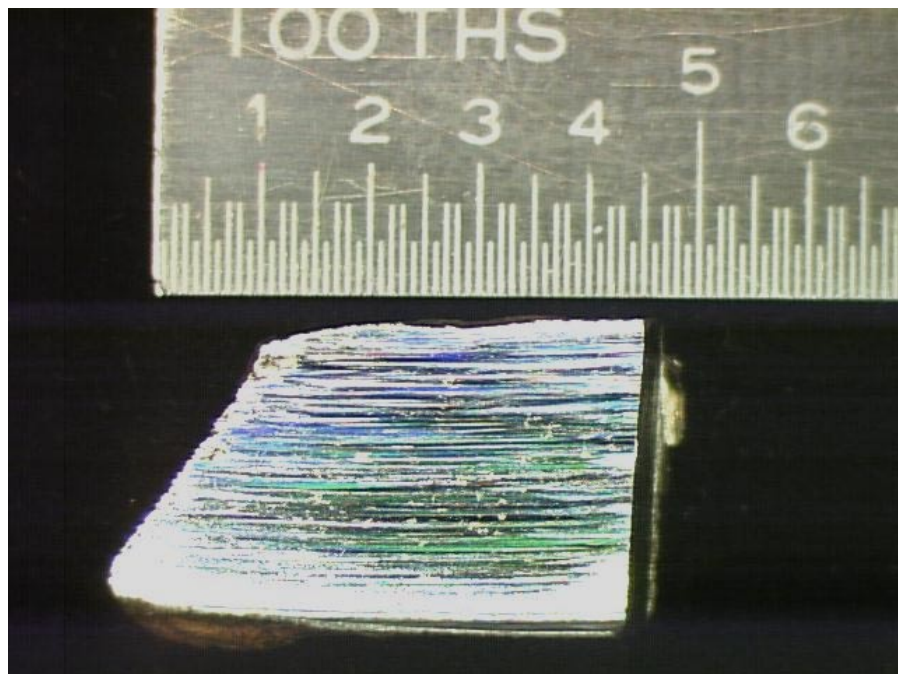
We then prepared for metallographic examination a small section you identified as as “Item 1,” which had been taken from a corner of Sample F1 by a transverse cut through its fracture surface. Relatively little pre-fracture necking had occurred (Figure 4), and relatively little elongation of the ferrite grains and pearlite colonies comprising the carbon steel microstructure was apparent (Figure 5). Fracture under shock loading conditions is

often associated with a localization of shear deformation that arises due to adiabatic conditions. In the present case it was impossible to determine whether a shear band was present at the fracture surface because of the corrosion that had occurred, but the absence of necking suggested its possibility.

Figure 4. Overall view of section taken from Sample F1, showing minimal pre-fracture necking.

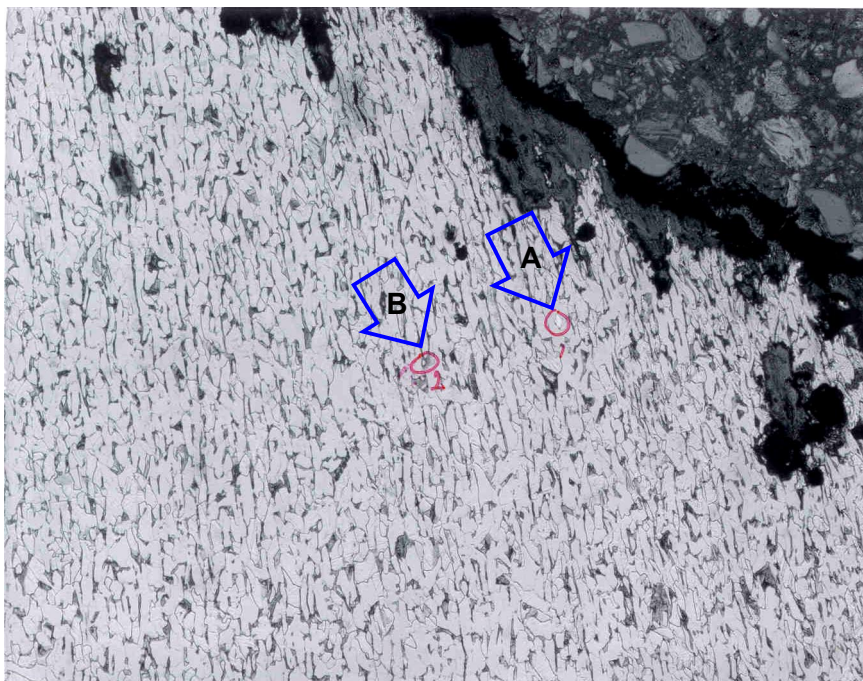
Figure 5. Optical micrograph showing typical microstructure along fracture surface of Sample F1 (100 \times).

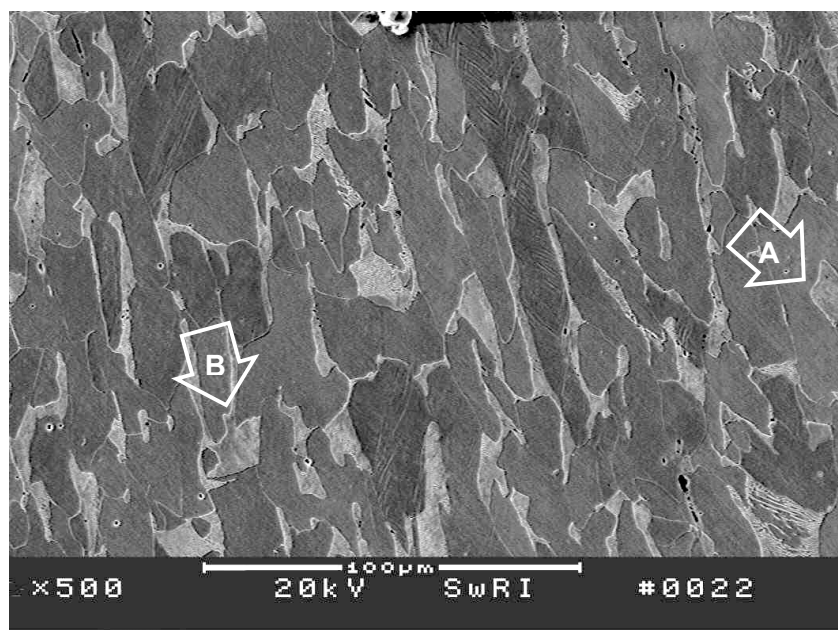
Another microstructural feature that can appear as a result of the adiabatic shearing and self-quenching process associated with shock-induced shear localization is that of untempered ("white") martensite. This is not a prevalent feature in ferrite-pearlite steels because of their sluggish transformation kinetics as compared to the tempered martensites commonly found in the higher carbon and alloy steels. In the present case there were a number of regions near the fracture surface, such as those indicated in Figure 5, whose response to etching suggested that some pearlite colonies may have undergone this process. However, closer examination of these areas by SEM proved otherwise, revealing them to be pearlite colonies merely having an extremely fine interlamellar spacing (Figures 6-8).

Figure 6. SEM micrograph showing ferrite-pearlite microstructure of Sample F1, as well as locations 'A' and 'B' in Figure 5.

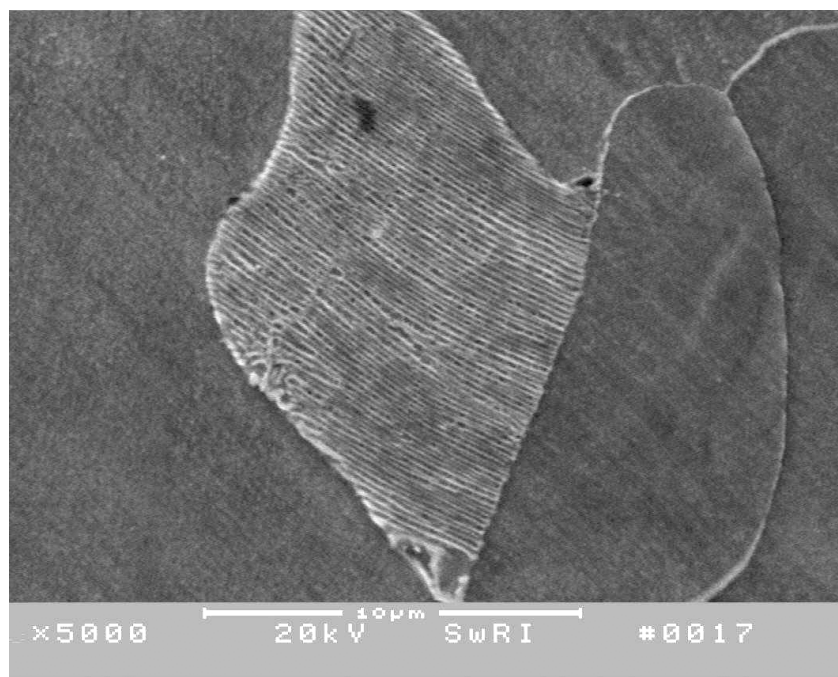
Figure 7. Highly magnified view showing detail of pearlite colony at location 'A' in Figure 6.

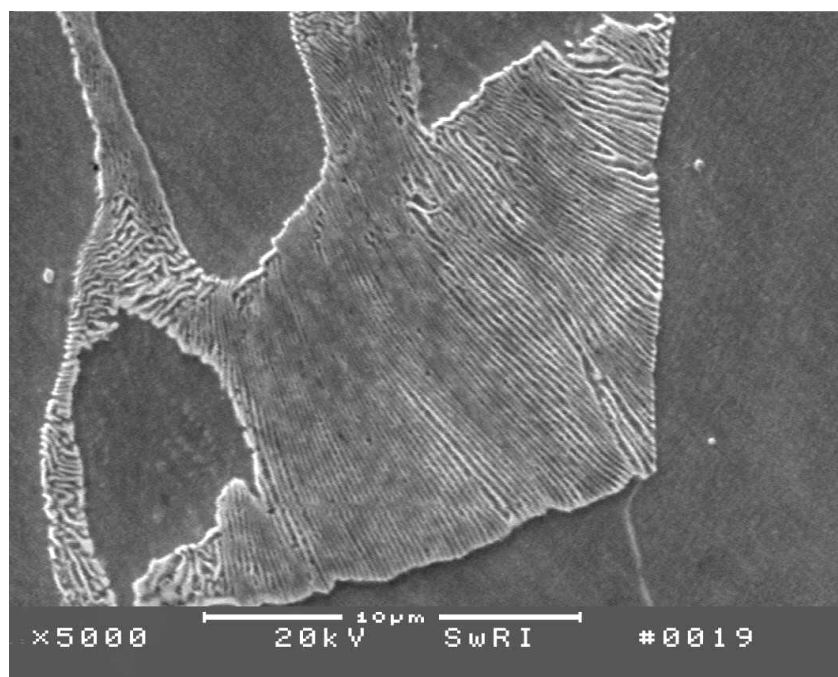
Figure 8. Highly magnified view showing detail of pearlite colony at location 'B' in Figure 6.

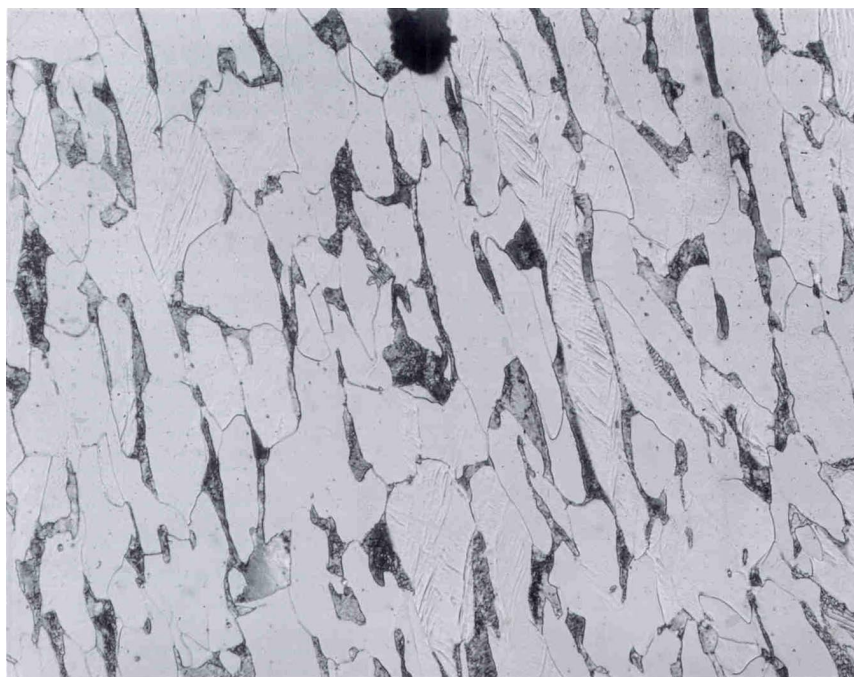
A potentially significant feature found in Sample F1 was the occurrence of deformation twinning. Twinned grains like those visible in Figure 9 were scattered along the plate thickness within a few millimeters of the fracture surface. This is a characteristic of extremely high strain rate conditions, assuming the ambient temperature at the time of failure was not cryogenic. In the present case we could not determine whether it resulted from shock loading or was simply the side effect of an unstable, fast-running shear fracture. This uncertainty was due to corrosion damage to the fracture surfaces and our inability to give context to the submitted samples, *i.e.*, to relate them to any surrounding structural damage or to the circumstances under which failure occurred. Further investigation is warranted, probably by experimenting with subsize tensile specimens that could be removed from the samples on hand.

1. One of the two submitted samples (F1) exhibited deformation twinning and minimal pre-fracture necking. If cryogenic temperatures and running shear fracture can be ruled out, these could be considered evidence of shock loading.
2. The second sample (H2) exhibited neither of the above characteristics of high-strain-rate deformation.

Figure 9. Optical micrograph showing typical evidence of deformation twinning in Sample F1 (500×).

3. The presence or absence of a shear band along both fracture surfaces, which would have helped to confirm or deny the possibility of shock loading, was masked by post-failure corrosion.
4. Additional experiments should be conducted to simulate the range of loading rates over which failure might have occurred. This would enable us to correlate microstructural features found in the submitted samples with those exhibited by samples generated under known conditions. A more detailed proposal can be provided upon your request.

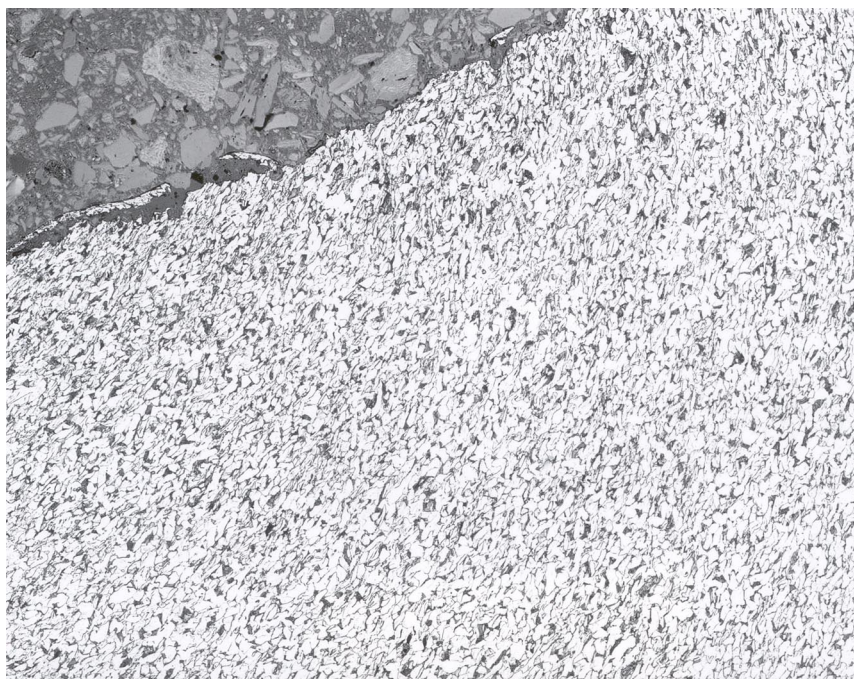
A similar metallographic section taken from Sample H2 exhibited a greater degree of necking and grain elongation away from the shear fracture surface (Figure 10), and deformation twinning was less readily apparent. Again, corrosion made it impossible to determine whether or not a shear band was present at the fracture surface.

Figure 10. Typical microstructure along fracture surface of Sample H2 (100×).
