# FAILURE ANALYSIS OF THE ESTONIA

*Metallurgical analysis of samples from the ferry Estonia demonstrates that it is much more likely than not that an explosion caused the characteristic signatures visible in these samples retrieved from the sunken vessel.*

Kent L. Johnson\*  
Kenneth M. Smith Jr.  
Engineering Systems Inc.  
Aurora, Illinois

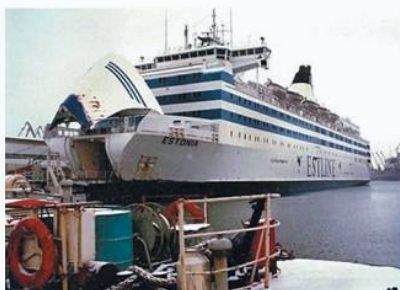
This is a photo of the ferry Estonia. Two samples were retrieved from a damaged area near the starboard forward bulkhead in a series of dives in the year 2000, six years after the ship sank. They are from the ship structure that would have been engaged with the bow visor, the portion of the ship that withstood the force of waves at the bow of the vessel. The visor is shown in the up position. At the time of Mr. Bemis's expedition to the ship, the bow visor was not present with the rest of the wreck.

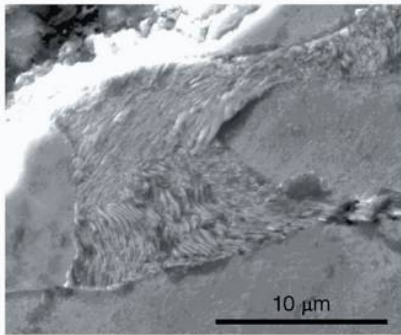
Fig. 1 — Deformed and broken pearlite lamellae, secondary electron image, sample F1. Note the presence of extremely fine lamellar pearlite. 10,000X

- The Material Testing Laboratory of the State of Brandenburg examined in detail one of the samples using a number of different specimens extracted from one of these samples. Those researchers reported that they observed severely deformed and broken pearlite lamellae at several locations (Fig. 1). Such severe deformation of the pearlite lamellae in areas adjacent to a rapidly traveling fracture surface is indicative of a very high strain rate, a potential characteristic of a possible detonation.

• First, there are several areas where the lamellar pearlite colonies were revealed to be distorted and broken up. This was found in the Brandenburg report and verified by this investigation with both of the specimens as shown in Fig. 1. This disruption of the pearlite lamellae is consistent with high strain rate deformation of the metal, such as by explosion.

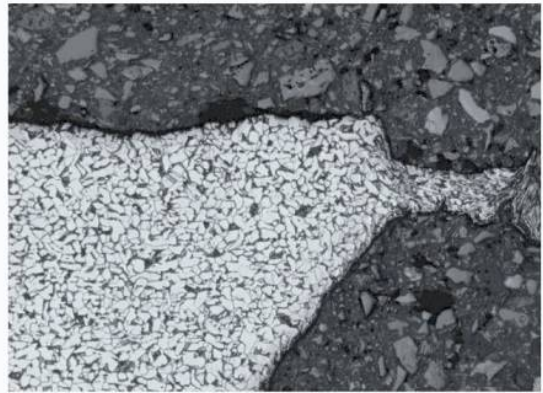
- The current investigation by ESI. Examination in this current investigation did verify the severe deformation and broken nature of some pearlite colonies near the fracture surfaces. Figure 2 shows a typical area of severely deformed and broken pearlite lamellae somewhat distant from the fracture surface. Figure 3 shows the metallographic microstructure of the St 37-2 steel in this current investigation. The microstructure consists of slightly banded lamellar pearlite in a matrix of fine-grained ferrite with elongated manganese sulfide inclusions. The grain size was determined to be slightly greater than ASTM No. 8. In several areas, the lamellar structure of the pearlite has been clearly distressed. The Brandenburg report observed the same thing, as documented in their scanning electron microscope (SEM) images.

Fig. 2 — Metallographic cross section sample F1. 100X 2% Nital etch.

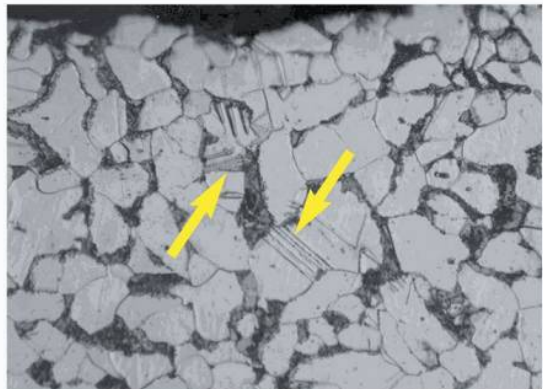
Fig. 3 — Sample F1 microstructure showing Neumann bands (yellow arrows) close to the fracture surface. Magnification 500X. 2% Nital etch.

the Brandenburg report, and the results of this current examination did reveal and document the presence of deformation twins or mechanical twins (i.e., Neumann bands) within the microstructure of the steel specimens. Figures 4 and 5 show the presence of Neumann bands (yellow arrows) within the sample at a location that is somewhat removed from (i.e., not at but close to) the fracture surface. This twinning was identified as Neumann bands, which in ferritic steels are caused by highly localized deformation associated with very fast brittle fracture or by very dynamic, high-energy-event stresses.

• Second, Neumann bands, or mechanical twinning in the ferrite phase of the metallurgical structure, were found at some distance from the actual fracture line. These features are also sometimes referred to as "impact twinning" or "deformation twinning." It is important that these Neumann bands were found at some distance away from the fracture surfaces, since two different operating mechanisms are involved. The one near the fracture surfaces would be adiabatic shear if high energy impact loading were involved. The one further away would be high strain-rate twinning resulting in the formation of Neumann bands. The locations distant from the fracture lines are not consistent with shot peening effects.

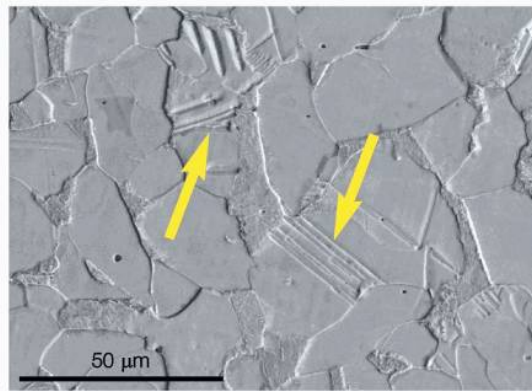
Fig. 4 — Sample F1, backscatter SEM image of Neumann bands shown in Fig. 3, magnification 2000X.

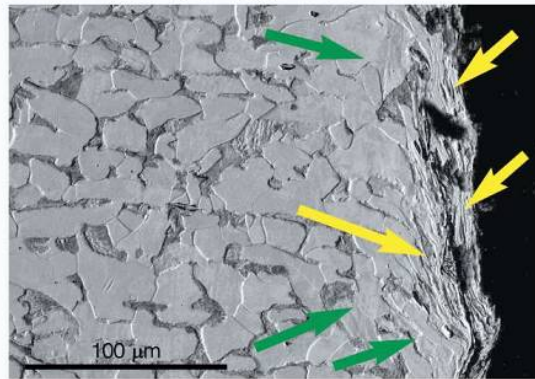
Fig. 5 — Potential severe plastic flow zone and wavy structure (yellow arrows) in a micro area of Specimen F1. Also shown are wavy slip lines (green arrows) within the grains close to the fracture surface. Backscatter electron image, magnification 1000X.

The Brandenburg report and the SwRI documents as well as the ESI study provide evidence regarding wavy slip planes and general shear bands within the microstructure. The current authors also found such features where it appears that the fracture surface was subject to impact during a high energy event. This is shown in Fig. 5.

• Third, the presence of wavy slip bands and localized severe shear bands within individual ferrite grains indicates the existence of very high mechanical strains at exceedingly high deformation strain rates (i.e., a high energy event). In addition to the evidence found by and presented in Fig. 5 of this report, both the Brandenburg report and the SwRI
