**Material Testing Laboratory  
of the State of Brandenburg -**

**Examination Report**

No. 1.3/00/3664

Contents Material examination of a part of the starboard front bulkhead  
of the ferry "Estonia" in order to prove mechanically caused  
structure deformations.

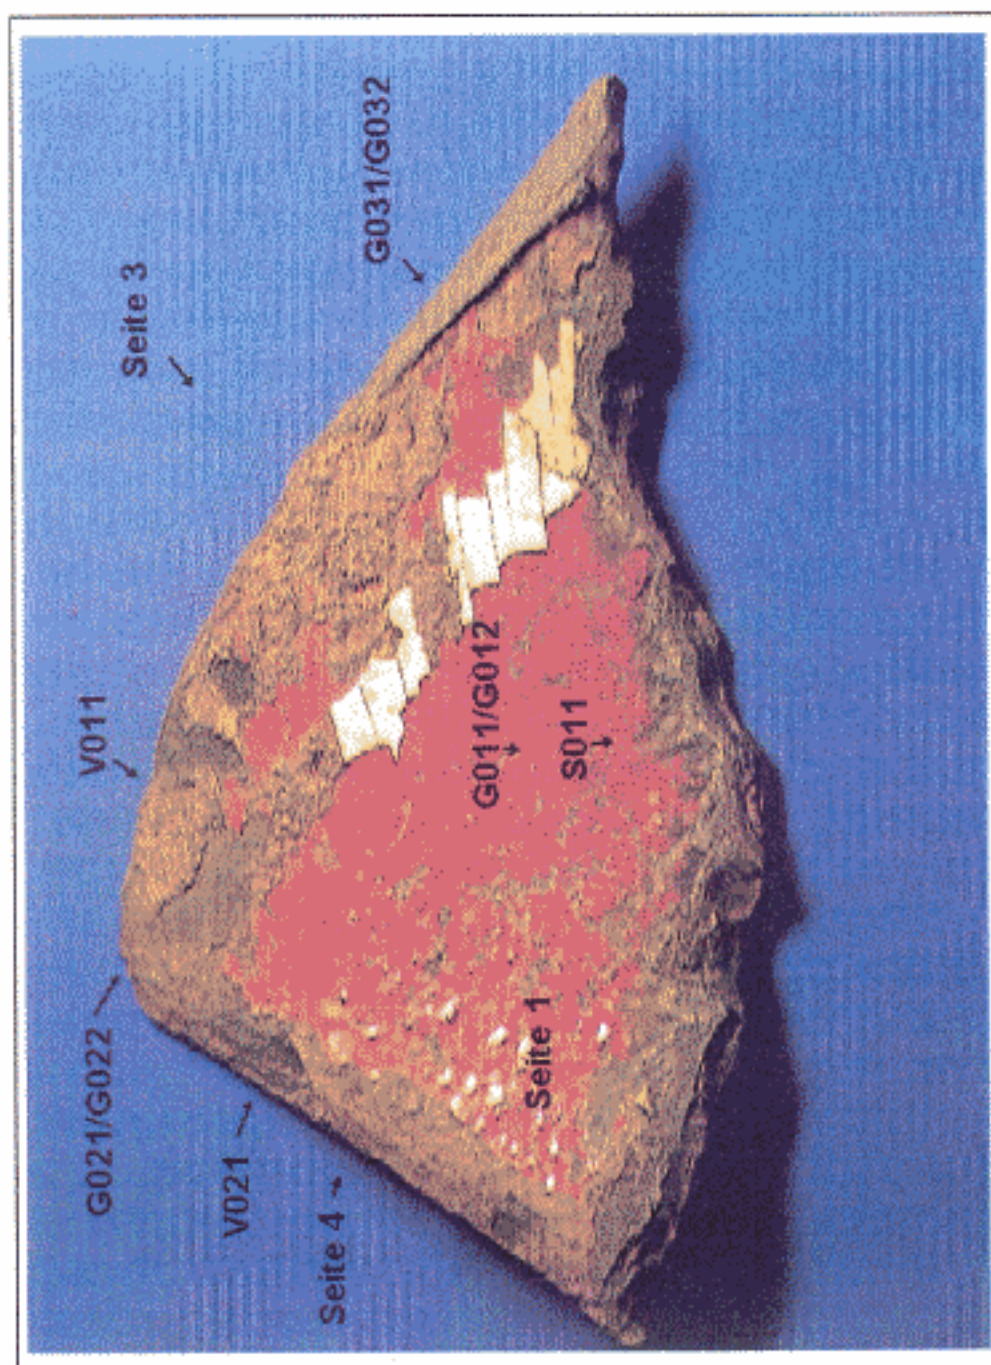
Bild 7 Probe 1.3/00/3664, Probenplan

The micro sections of specimen 13/00/3664 G021 and 13/00/3664 G022 as well as 13/00/3664 G031 and 13/00/3664 G032 have been taken from the fracture areas of the steel sample (sample plan, picture 7).
