**Material Testing Laboratory  
of the State of Brandenburg -**

**Examination Report**

No. 1.1/00/3669

Contents Material examination of a part of the starboard front bulkhead  
of the ferry "Estonia" in order to prove mechanically caused  
structure deformations additional examinations as to order  
1.3/00/3664.

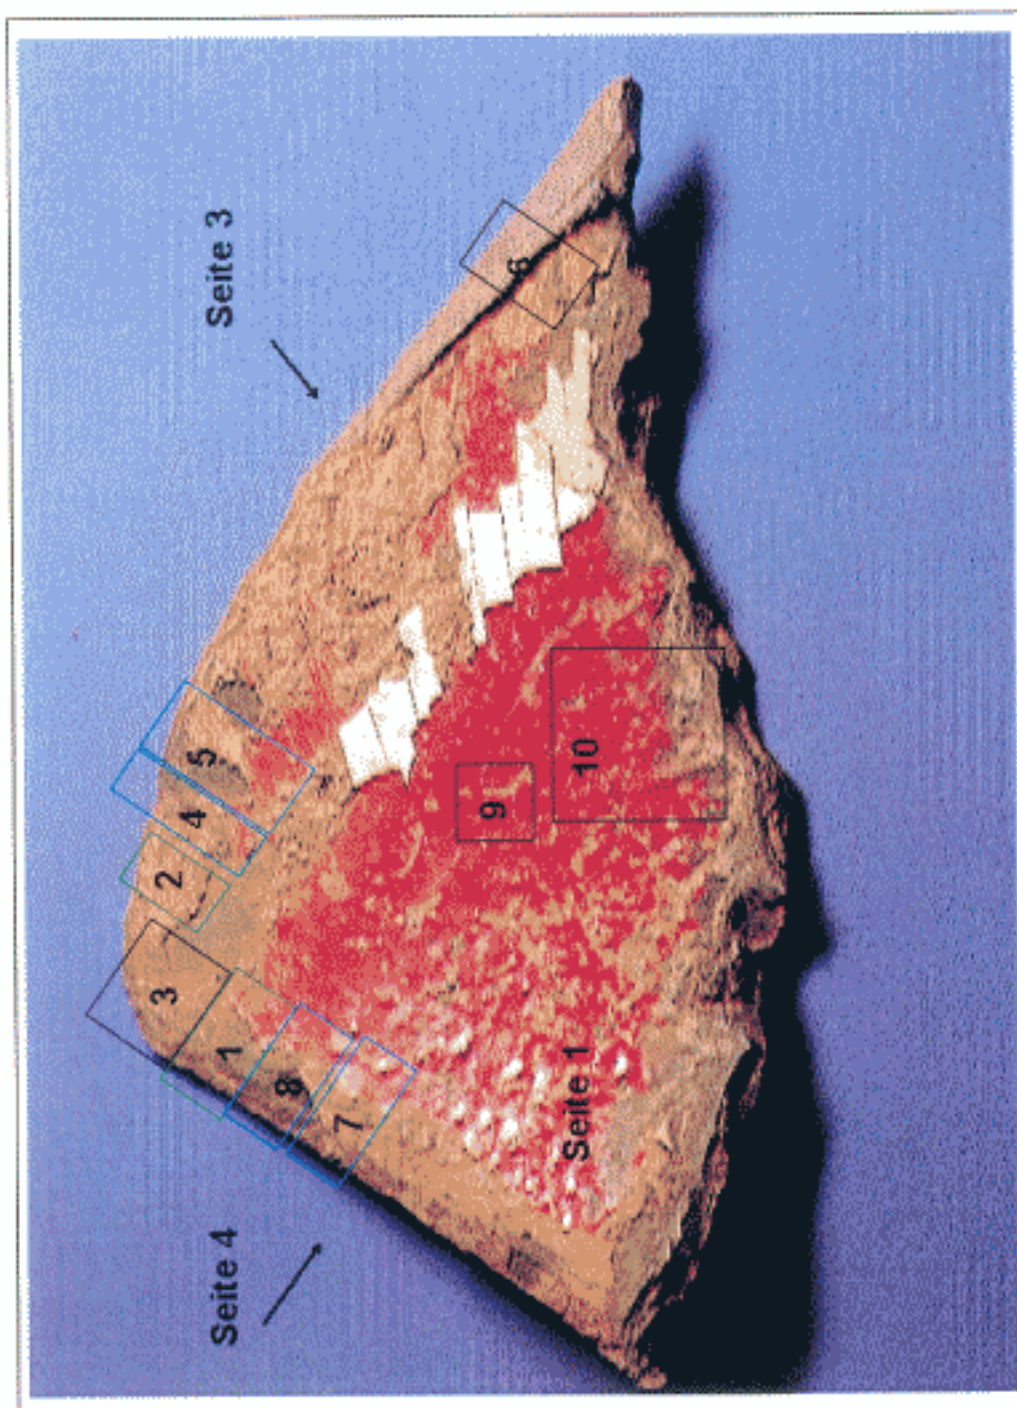
Bild 1 Probenplan, ca. 1:1, Aufteilung der Proben: Nr.: 1, Nr.: 2, Übergabe an den Auftraggeber  
 Nr.: 3, Nr.: 6, Nr.: 9, Nr.: 10, MPA, Auftrag 1.3/00/3664  
 Nr.: 4, Nr.: 5, Nr.: 7, Nr.: 8, MPA, Auftrag 1.1/00/3669

For the additional examinations within the range of this order, a specimen, viz. GO22 from order 1.3/00/3664 was used. Four specimens for cross micro-sections and longitudinal micro-sections have been taken out of this part sample.

The complete sample plan is shown on picture 1 and Table 1.
